**BYPASS ROUTES 1 AND 2; TREE INVENTORY
AND ANALYSIS REPORT**

Puget Sound Energy – Energize
Eastside Project

July 2016

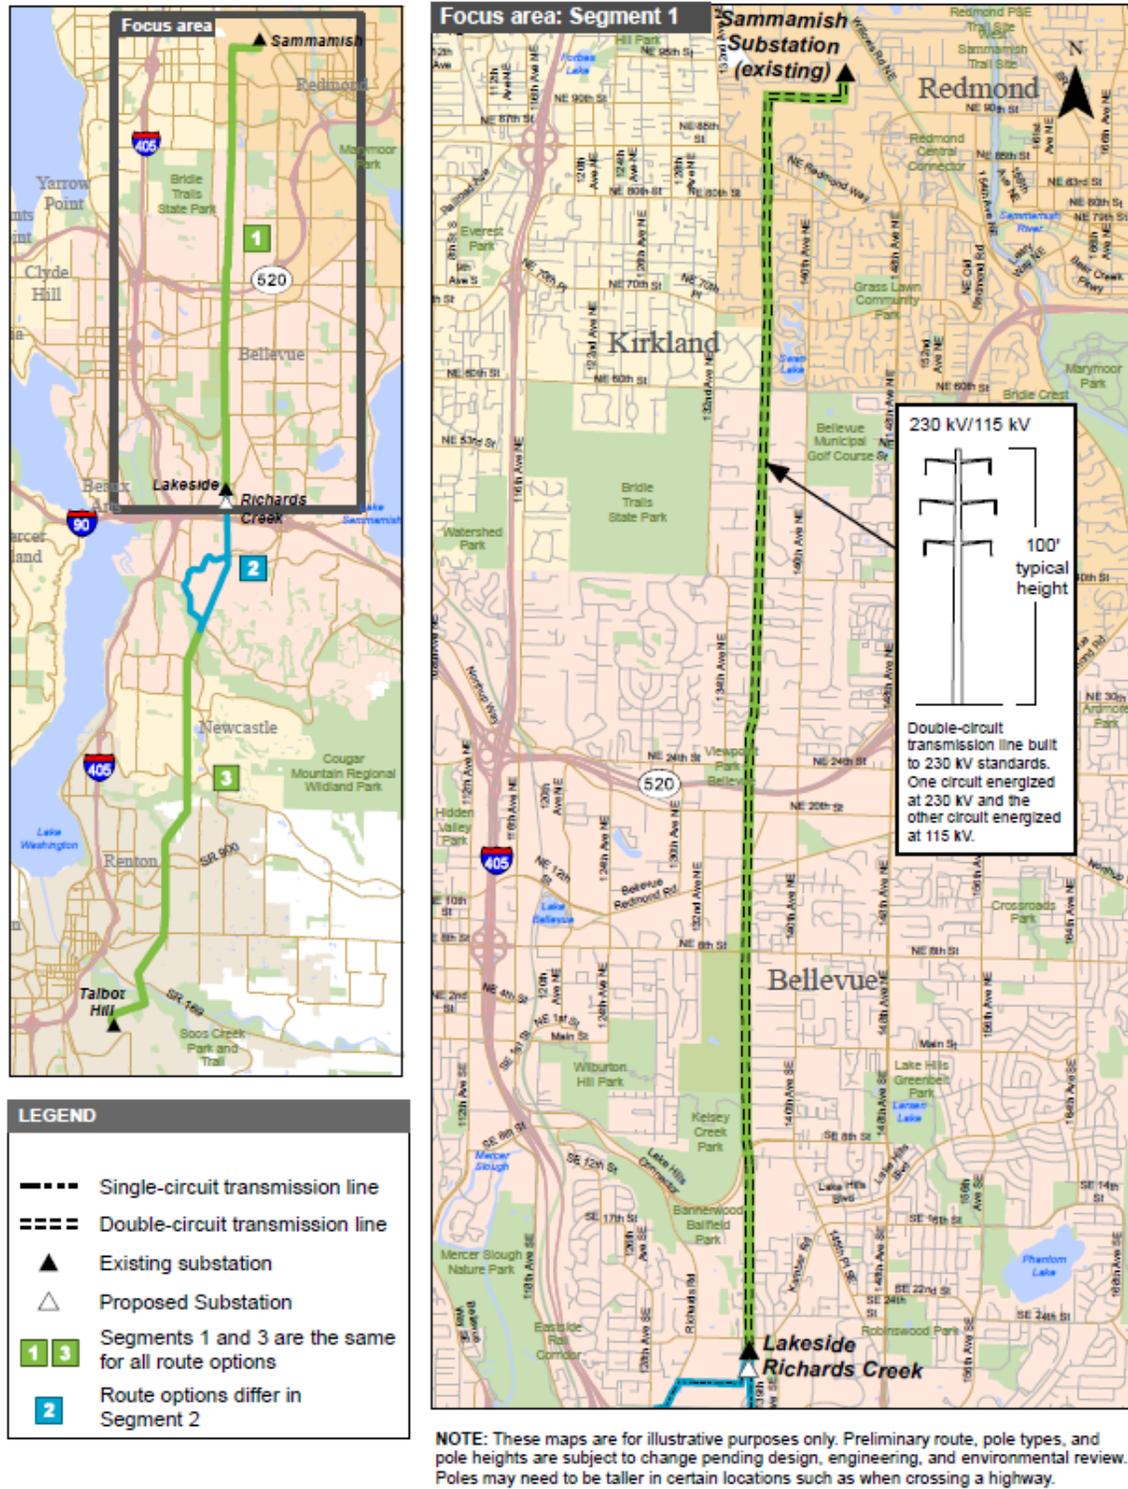
Figure 1 - An overview map showing the proposed Willow 2 Route. The Bypass Routes would provide an alternative to a portion of the route shown. (Energize Eastside, 2016)

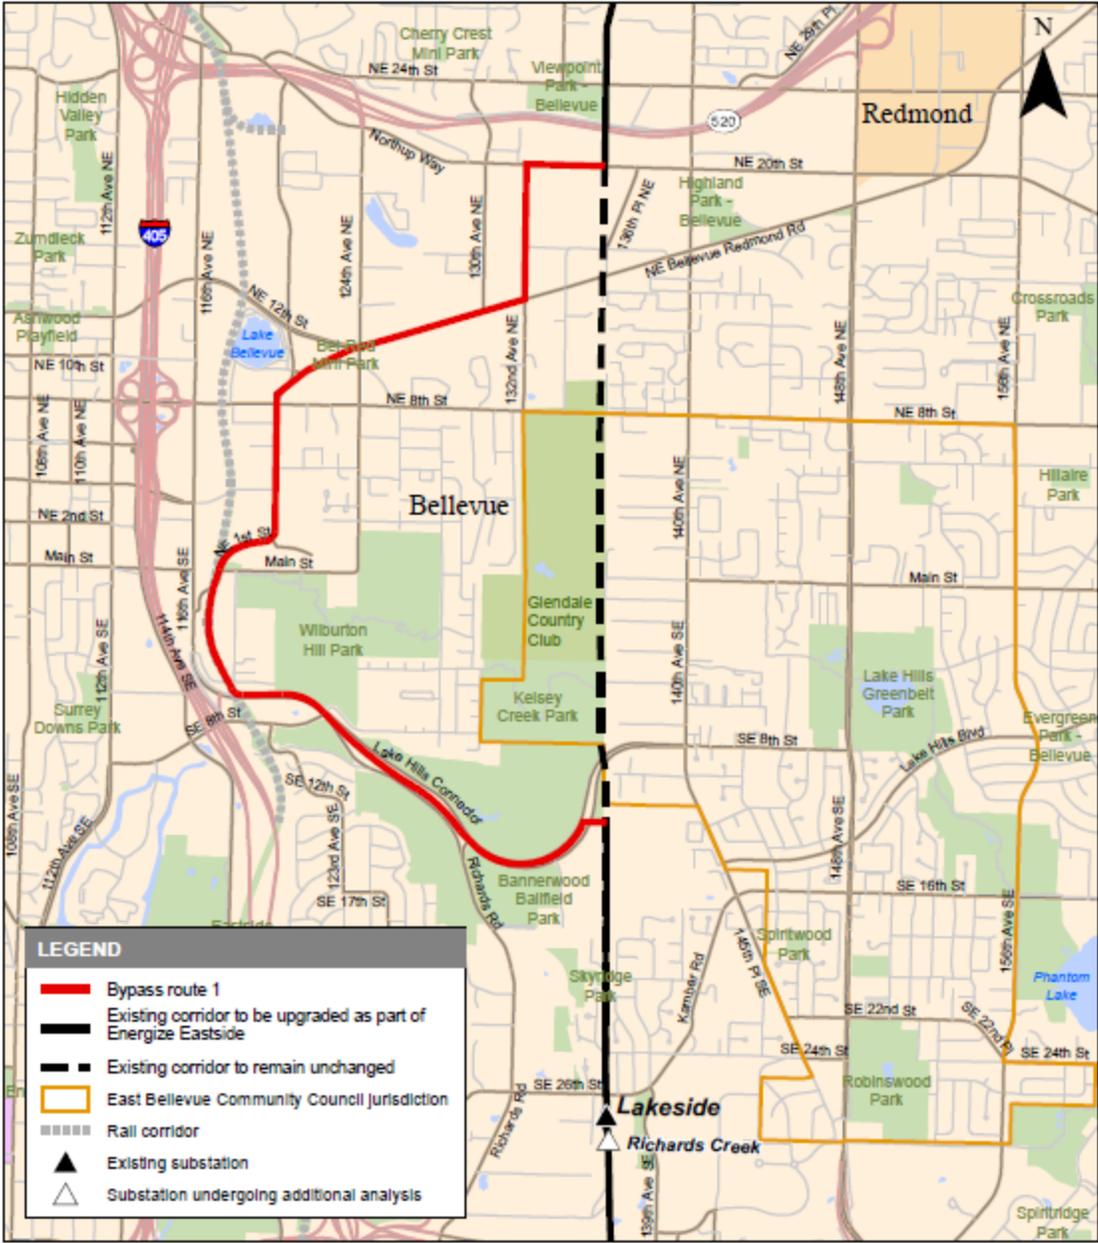
Figure 2 – A map showing Bypass Route 1 (red). (Energize Eastside, 2016)

The Bypass 1 alignment is shown in Figure 2. It arcs around the portion of the existing ROW through the Bel-Red, Wilburton and Woodridge neighborhoods, making a connection to the ROW at Northup Way in the north and just south of Lake Hills Connector in the south. Bypass 2 is shown in Figure 3. It follows the Bypass Route 1 alignment but diverges to meet the Lakeside Substation via Richards Road and SE 26th Street. Bypass 1 is approximately 3.9 miles in length. Bypass 2 is approximately 4.5 miles in length. The shared portion of the alignment is approximately 3.4 miles.

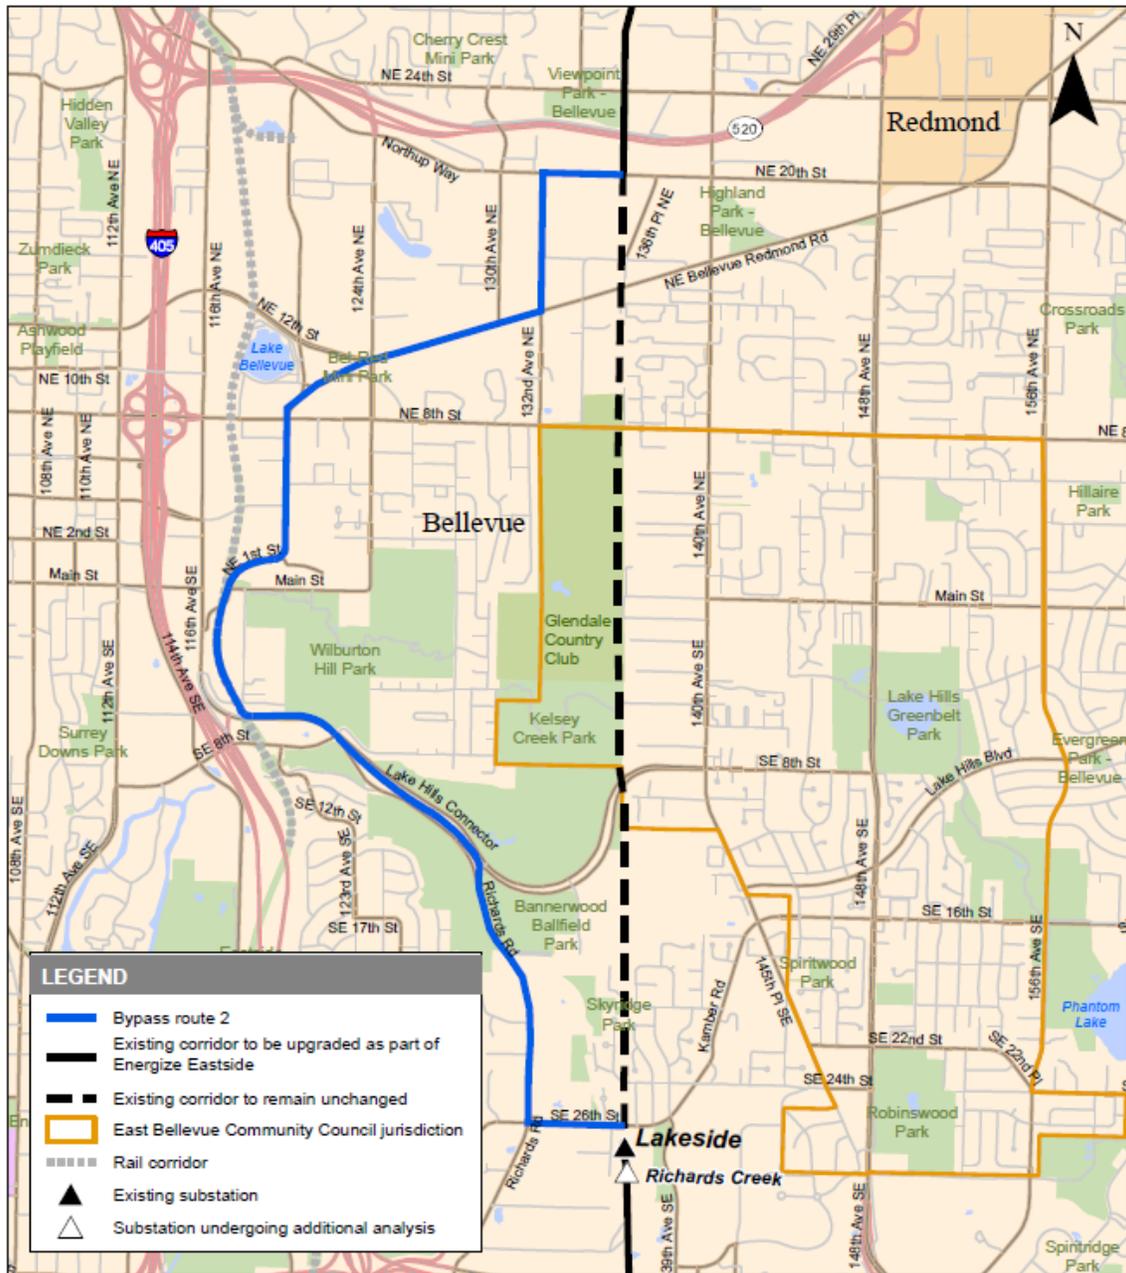
Figure 3 - A map showing Bypass Route 2 (blue). (Energize Eastside, 2016)

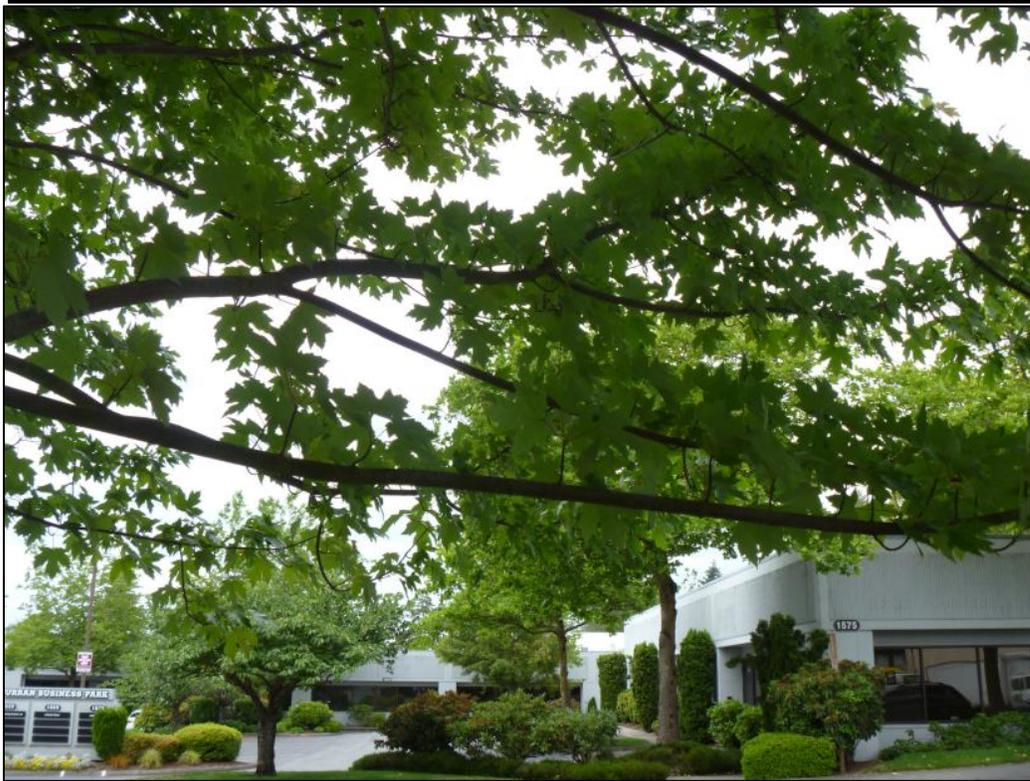
Figure 4 – A sugar maple street tree growing along 130th Ave NE (Photo taken June 8, 2016)

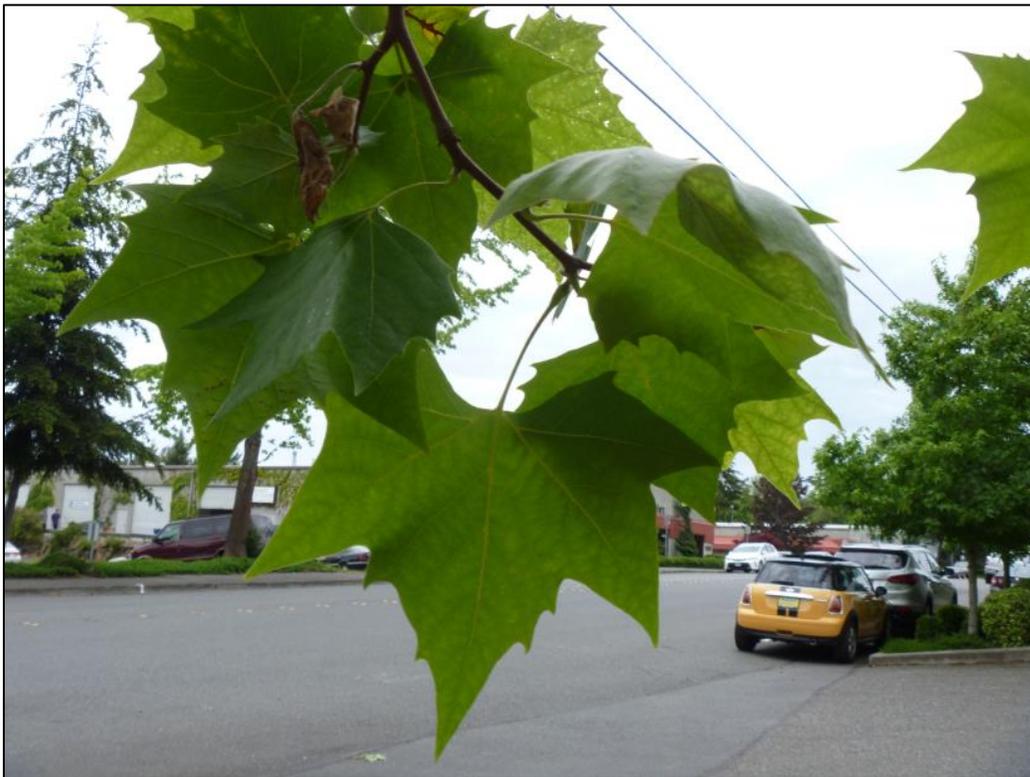
Figure 5 - An American sycamore growing as a street tree along 130th Ave NE. (Photo taken on June 8, 2016)

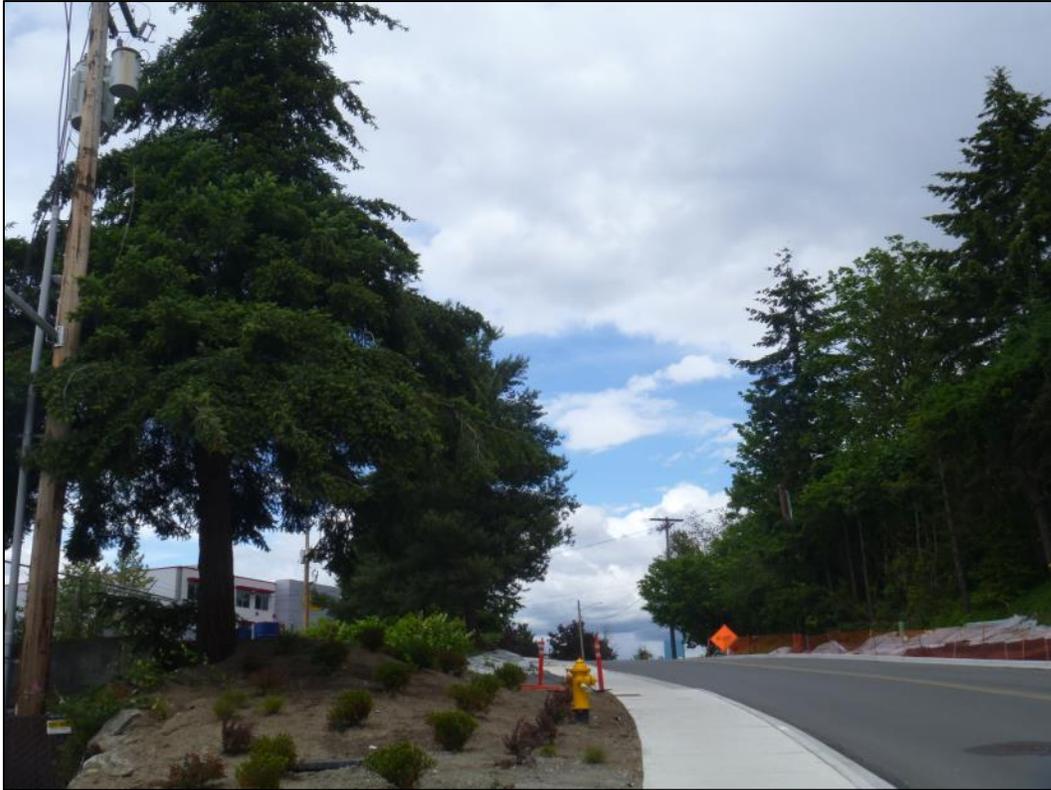
Figure 6 - A Douglas-fir and new landscaping along Bel-Red Road. (Photo taken on June 10, 2016)

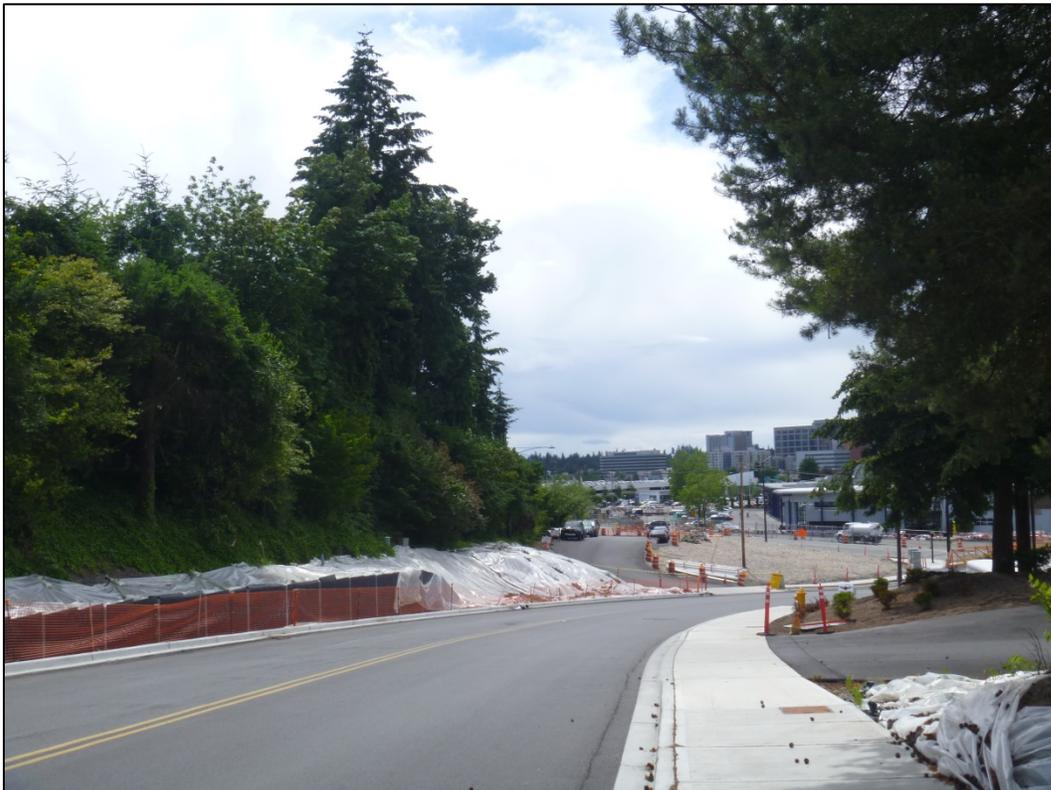
Figure 7 - A recently re-aligned section of Bel-Red Road. (Photo taken on June 10, 2016)

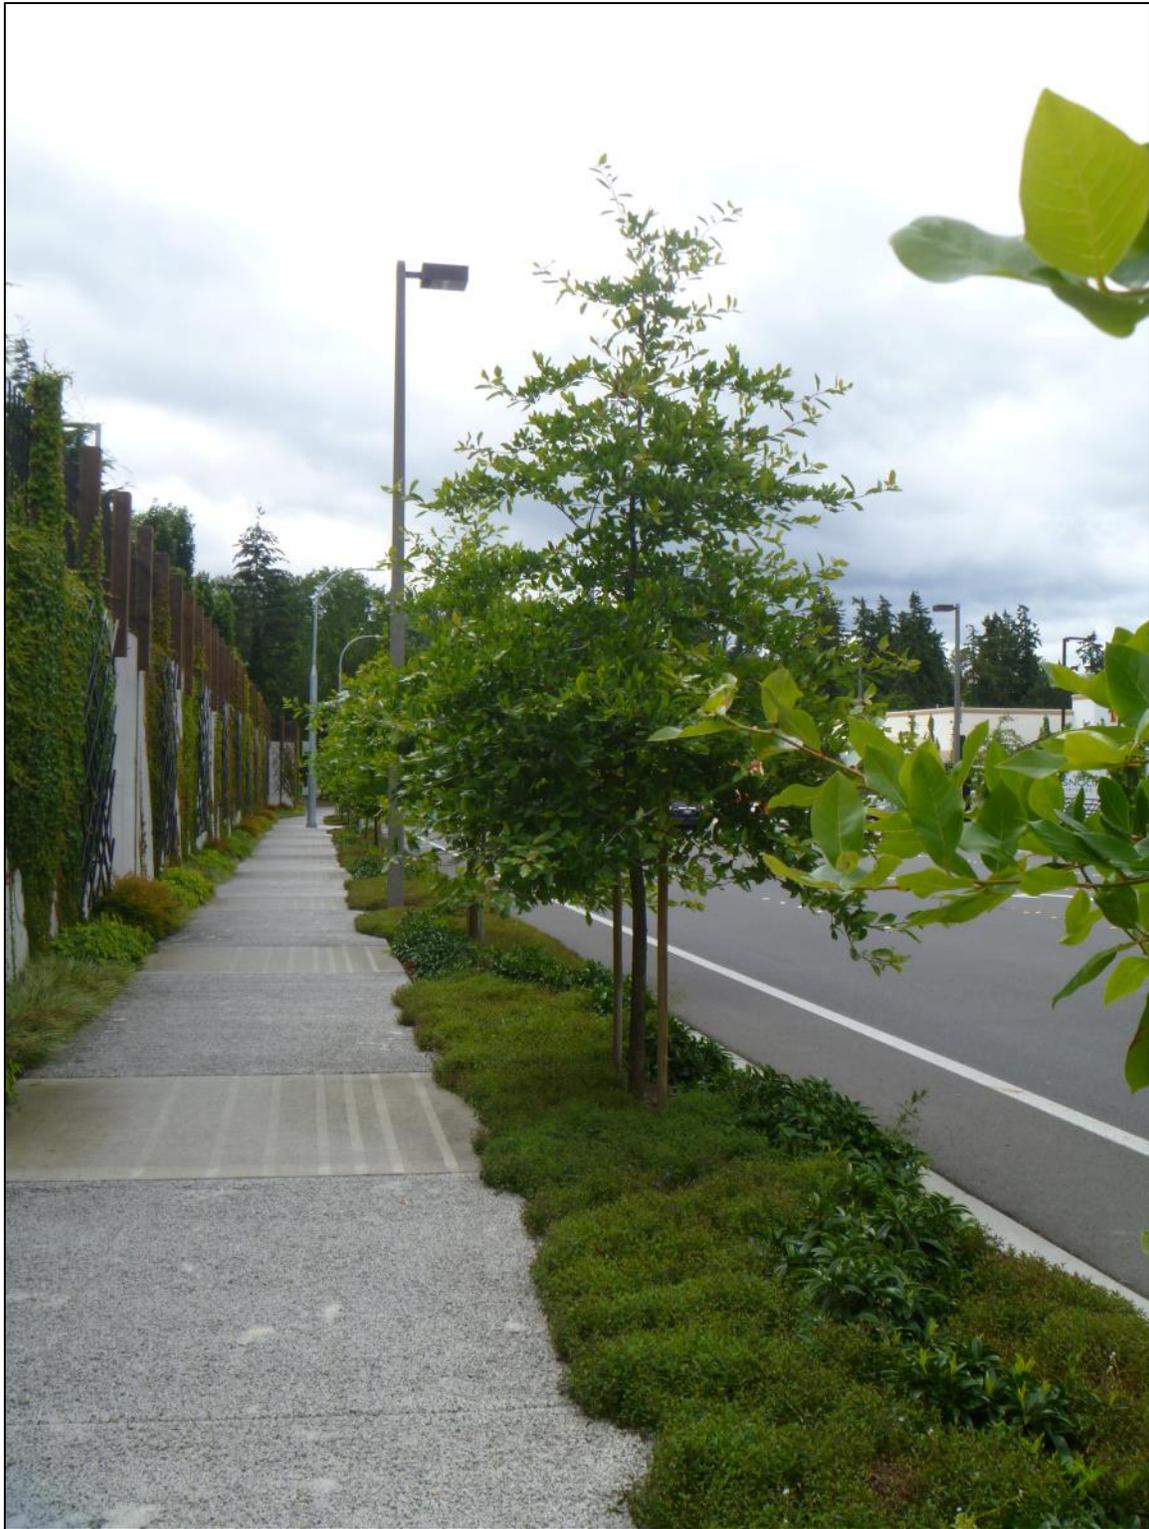
Figure 8 - A row of black tupelo street trees along 120th Ave NE (Photo taken on June 13, 2016)

Many of the species found in the Bel-Red and Wilburton Neighborhoods are London plane, red maple, Douglas-fir and sweet cherry trees. Many newly-installed trees were located and assessed along the roadways in the Bel-Red and Wilburton neighborhood, including a row of several black tupelos along 120th Ave NE (tree numbers 8743 – 8871).

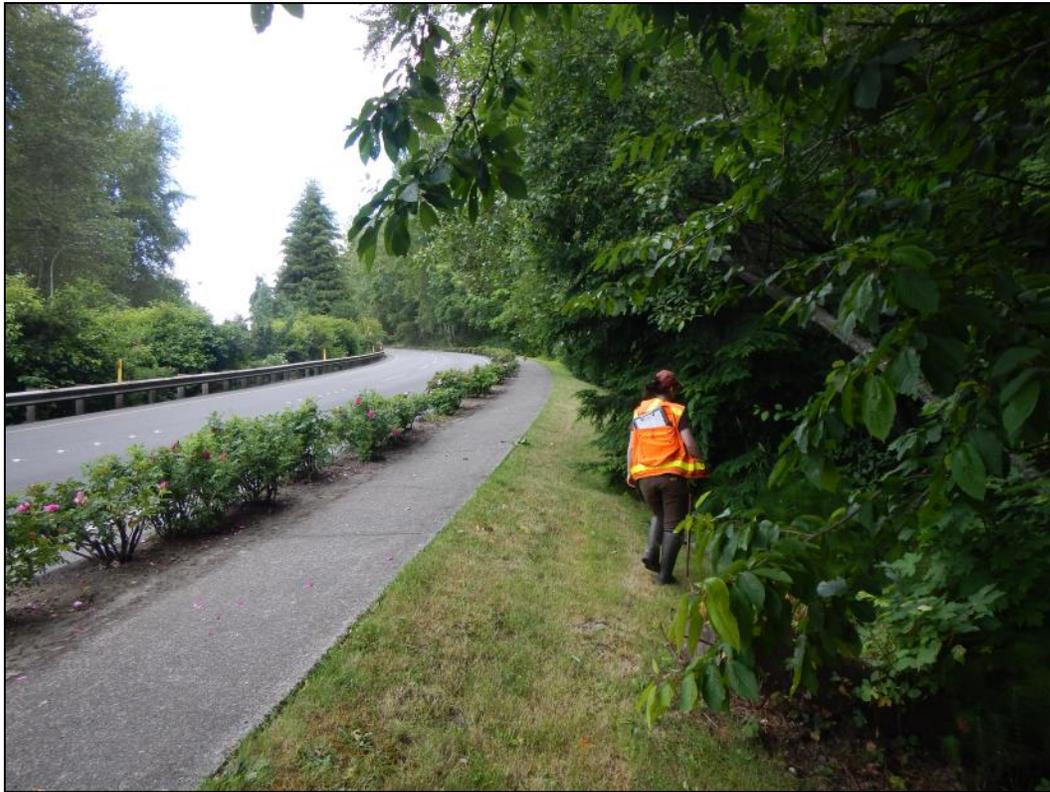
Figure 9 – A natural area north of the west-bound lanes of Lake Hills Connector (Photo taken on June 15, 2016)

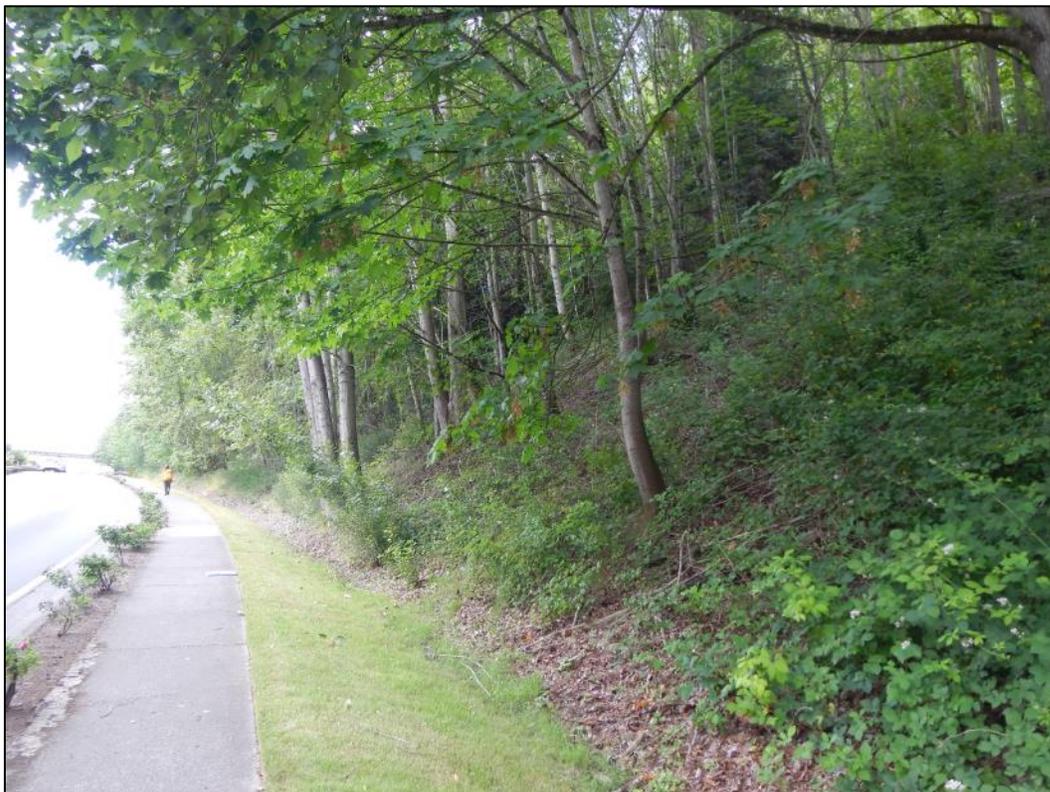
Figure 10 - Looking southeast along the east-bound lanes of Lake Hills Connector showing several big leaf maple trees. (Photo taken on June 15, 2016)

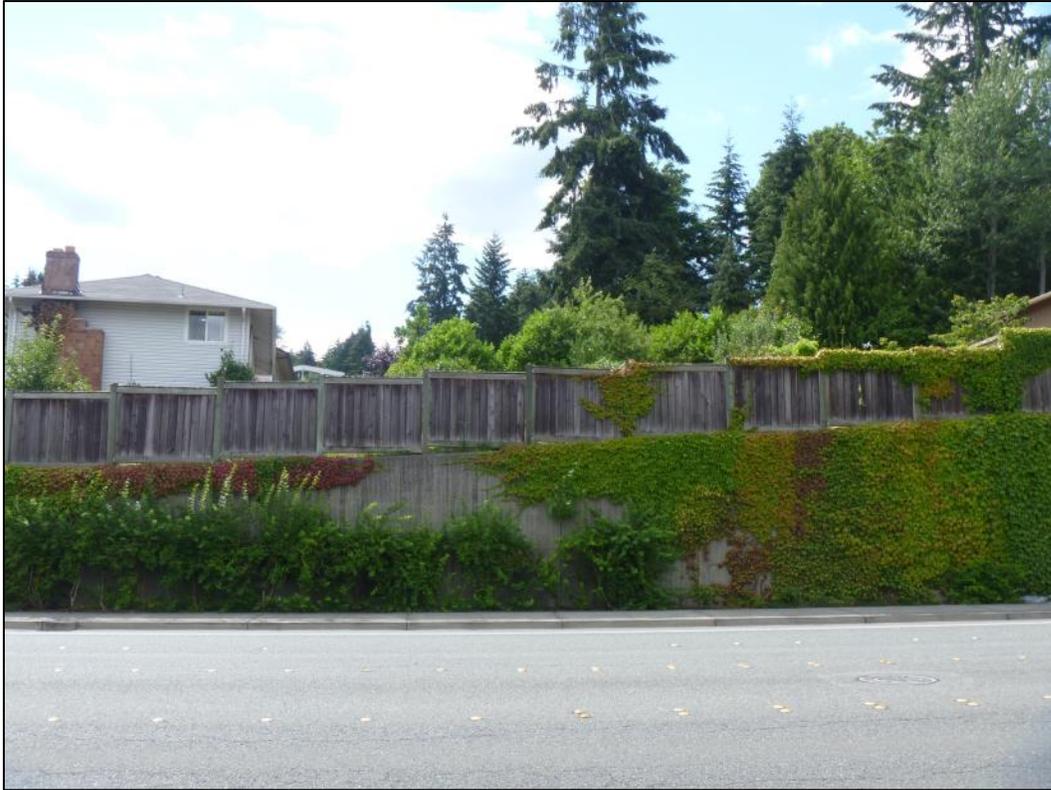
Figure 11 - A retaining wall, fence and vegetation in a residential neighborhood along Richards Road. (Photo taken on July 11, 2016)

Bypass Routes 1 and 2 are located within the Bellevue neighborhoods of Bel-Red, Wilburton and Woodridge. The north half of the study area (through Bel-Red and Wilburton) is zoned commercial and office and contains largely office park landscaping with lawns, street trees and perimeter landscape shrubs and trees (Figure 4, Figure 5, Figure 6, Figure 7 and Figure 8). The Woodridge neighborhood is zoned residential and is composed mostly of natural wooded areas (along Lake Hills Connector) (Figure 9 and Figure 10) and some residential landscaping along Richards Road and SE 26th Street (Figure 11 and Figure 12).

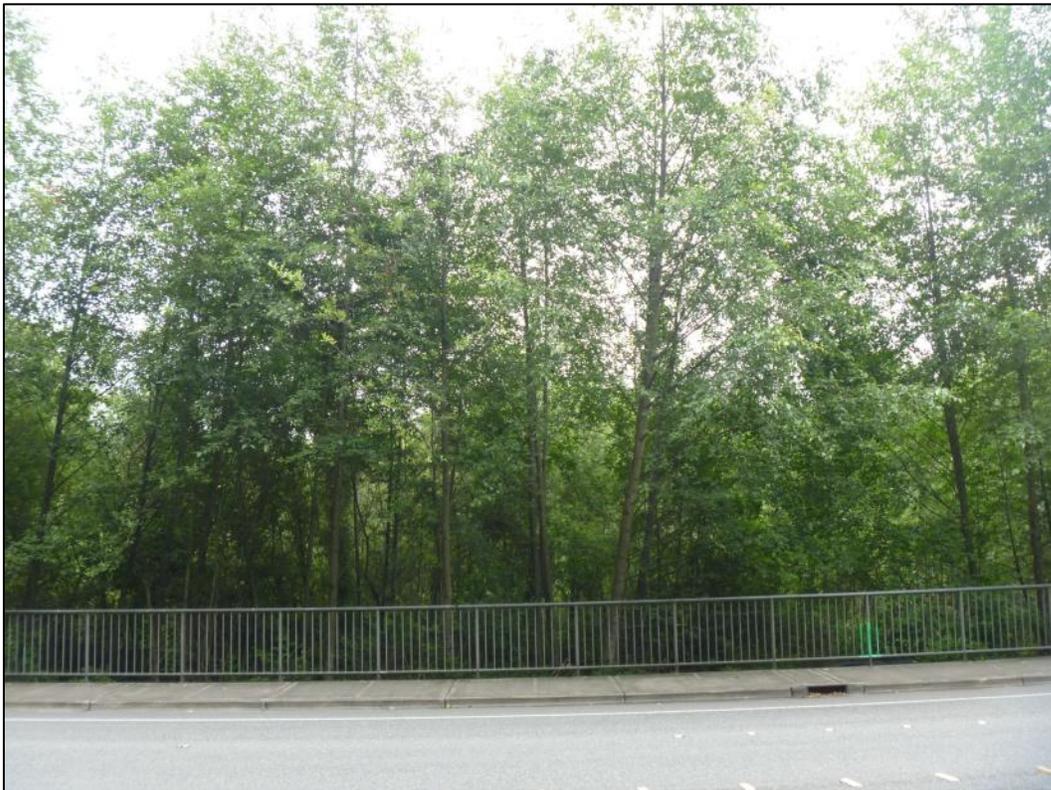
Figure 12 - A stand of five- to eight- inch red alder trees growing on the west side of Richards Road.(Photo taken on July 11, 2016)
