# CITY OF BELLEVUE TREE INVENTORY REPORT

## Puget Sound Energy – Energize Eastside Project

May 2016

### 1 EXECUTIVE SUMMARY

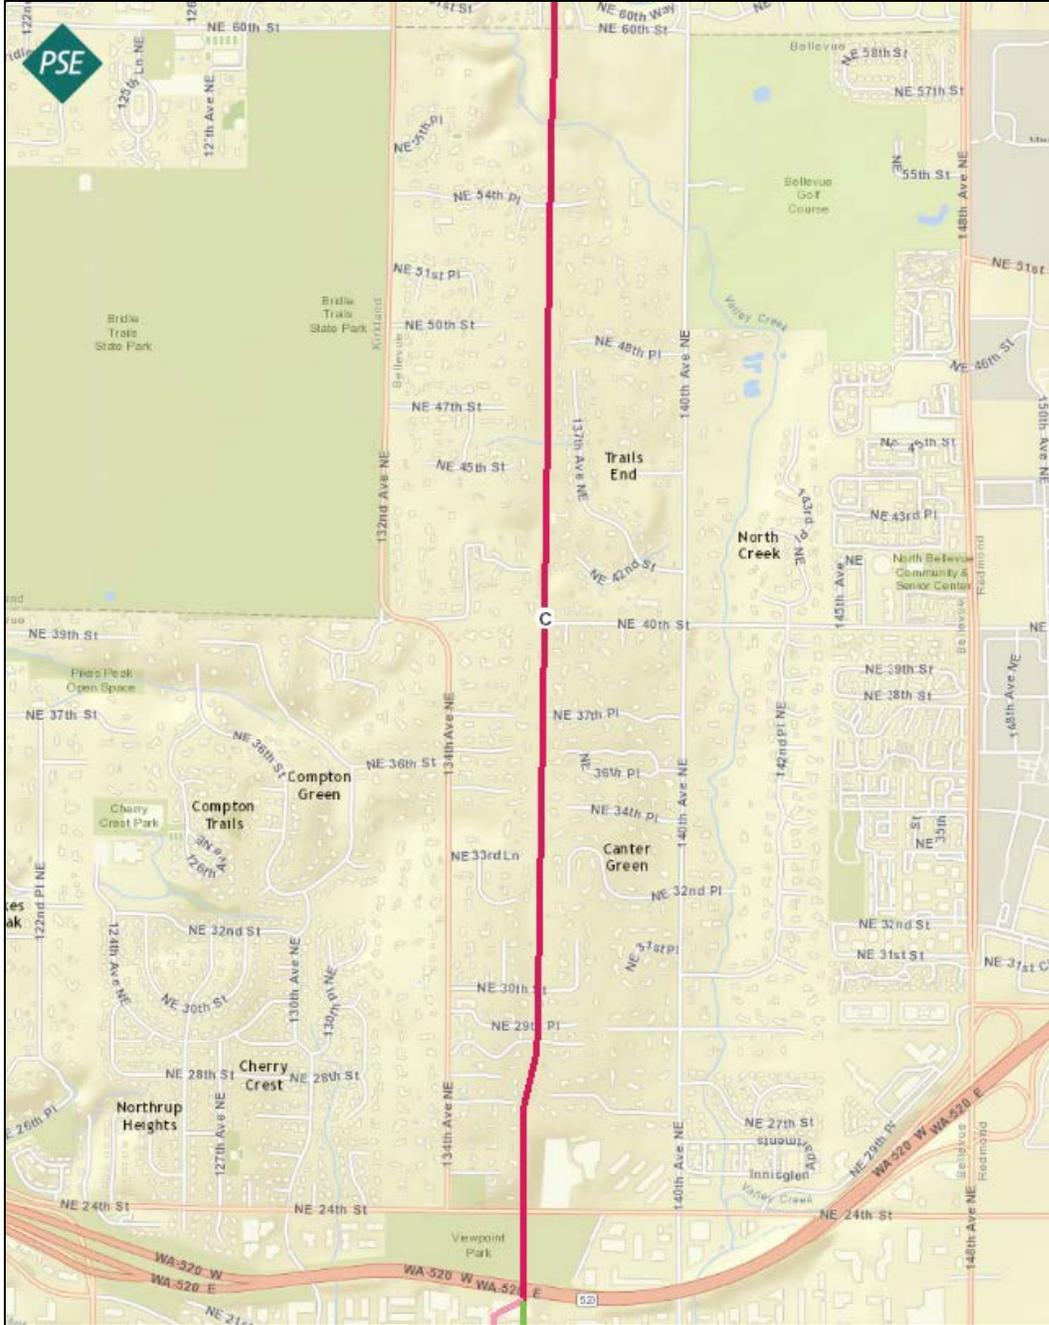
Figure 2 - Energize Eastside study area corridor (Segment C) in the City of Bellevue north of WA-520.

The City of Bellevue portion includes PSE-labeled Segments C, E, G2, I, K2, M, and J (Figures 2, 3, 4, and 5), portions of Phase 2 DEIS Segments 1, 2 and 3. The length of the study area corridor in the City of Bellevue totals approximately 11.3 miles from NE 60th Street to SE 69th Way. For Segments C, E, J and M, the study area corridor is an approximately 100-foot wide easement that includes two existing sets of 115kV transmission lines. These sets, consisting of three conductors (wires) each, are spaced approximately 50 feet apart on-center; H-frame pole structures carry each set of transmission lines.

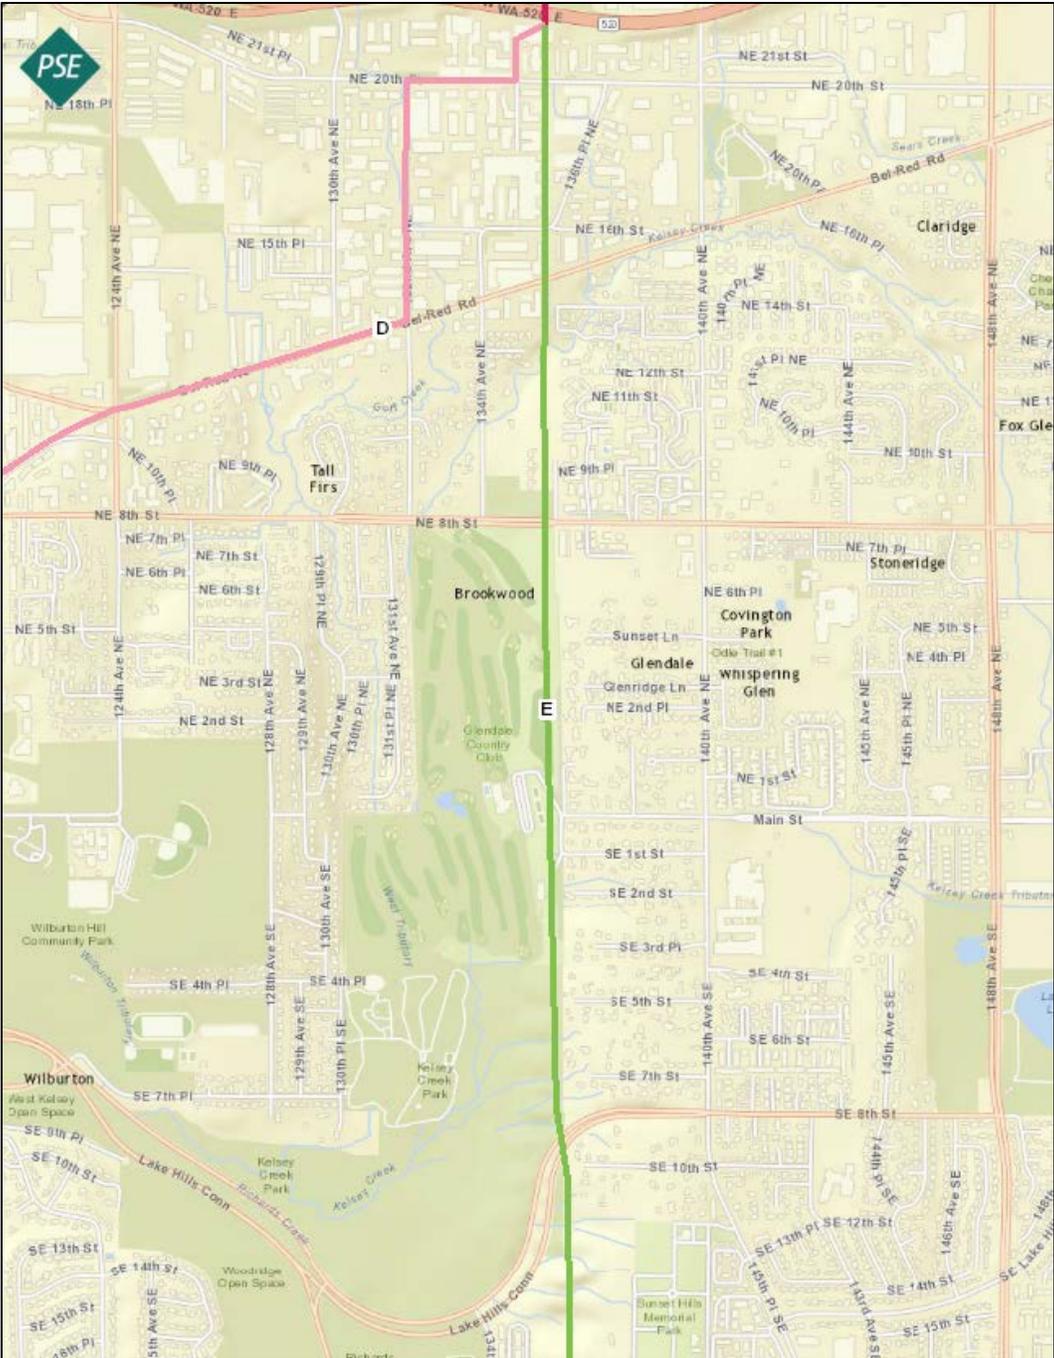
Figure 3 - Energize Eastside study area corridor (Segment E) in the City of Bellevue between WA-520 and Lake Hills Connector.

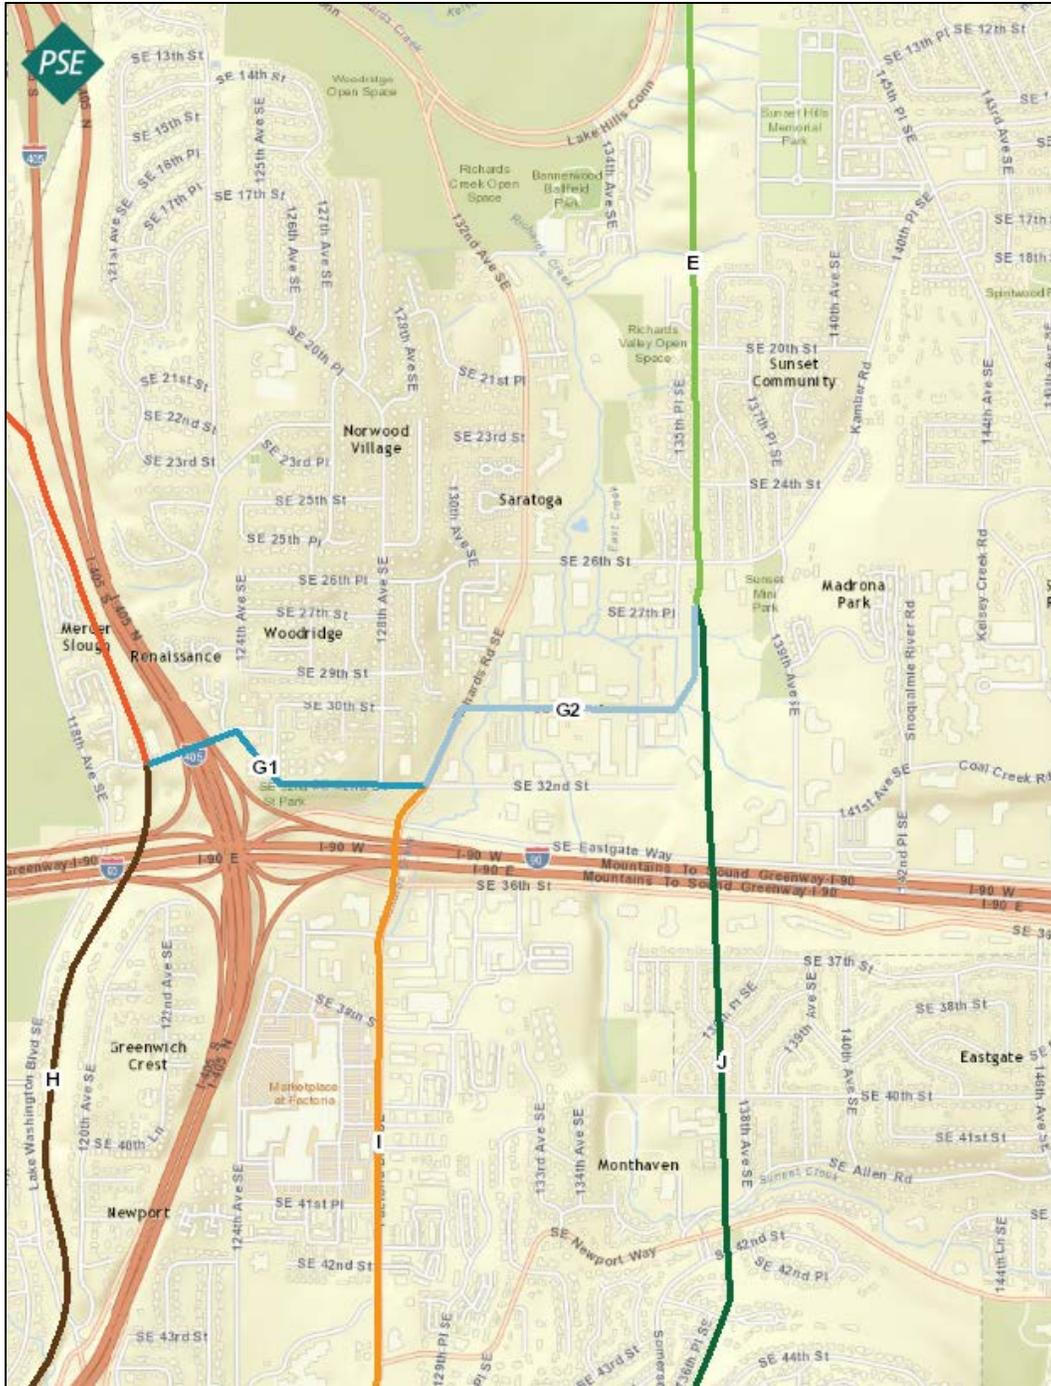
Figure 4 - Engize Eastside study area corridor (Segments E, J, G2, and I) in City of Bellevue in the vicinity of I-90.

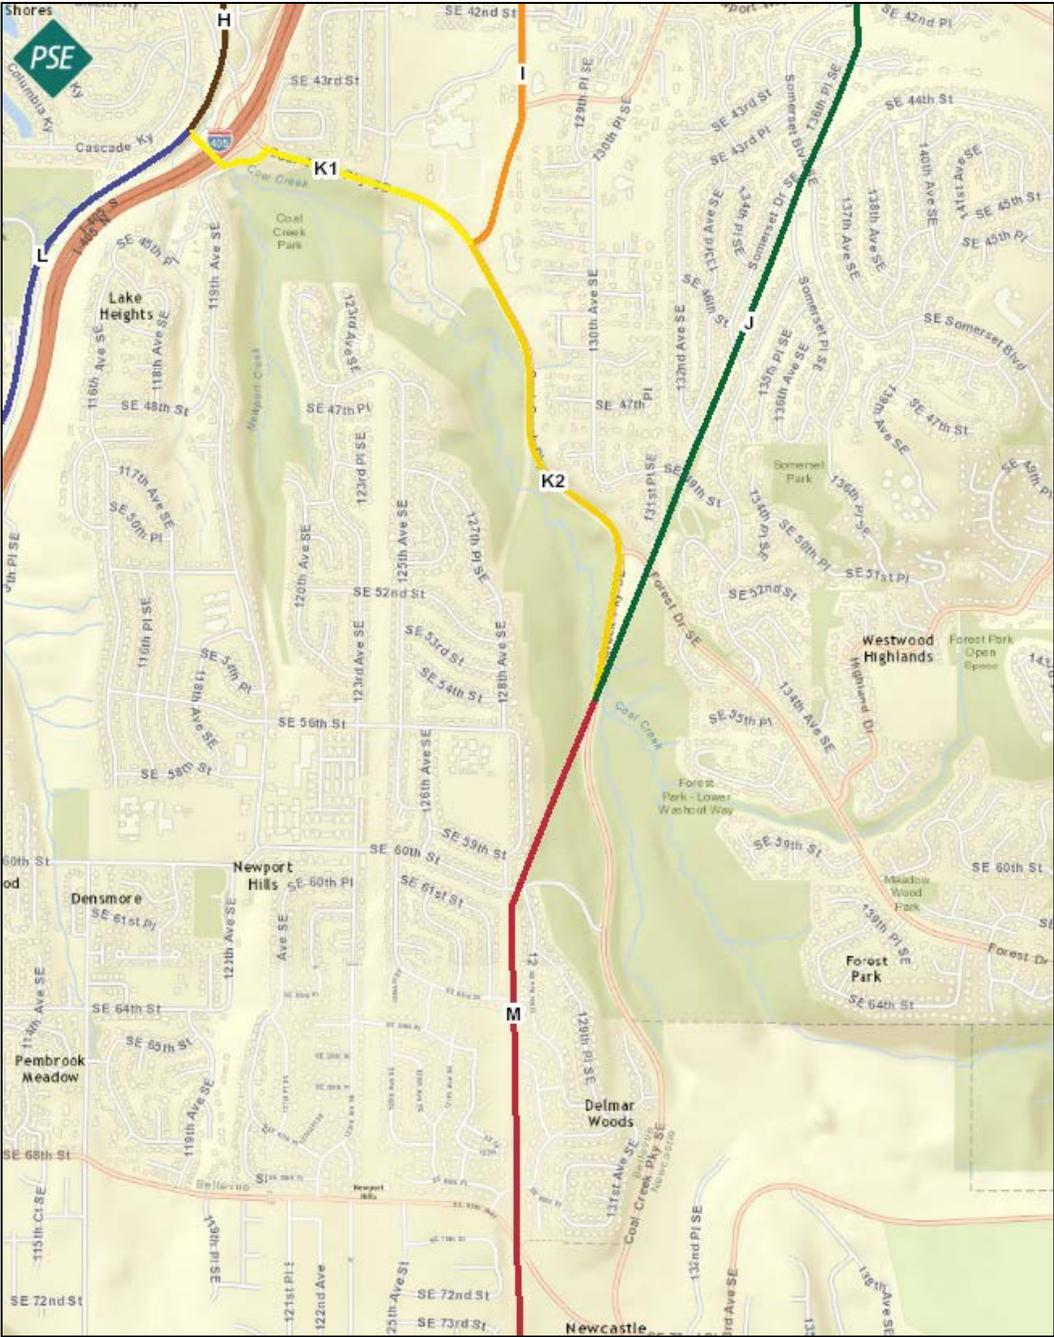
Figure 5 - Energize Eastside study area corridor (Segment J, I, K2, and M) in the City of Bellevue north of SE 69th Way. This is the southern extent of the City of Bellevue.

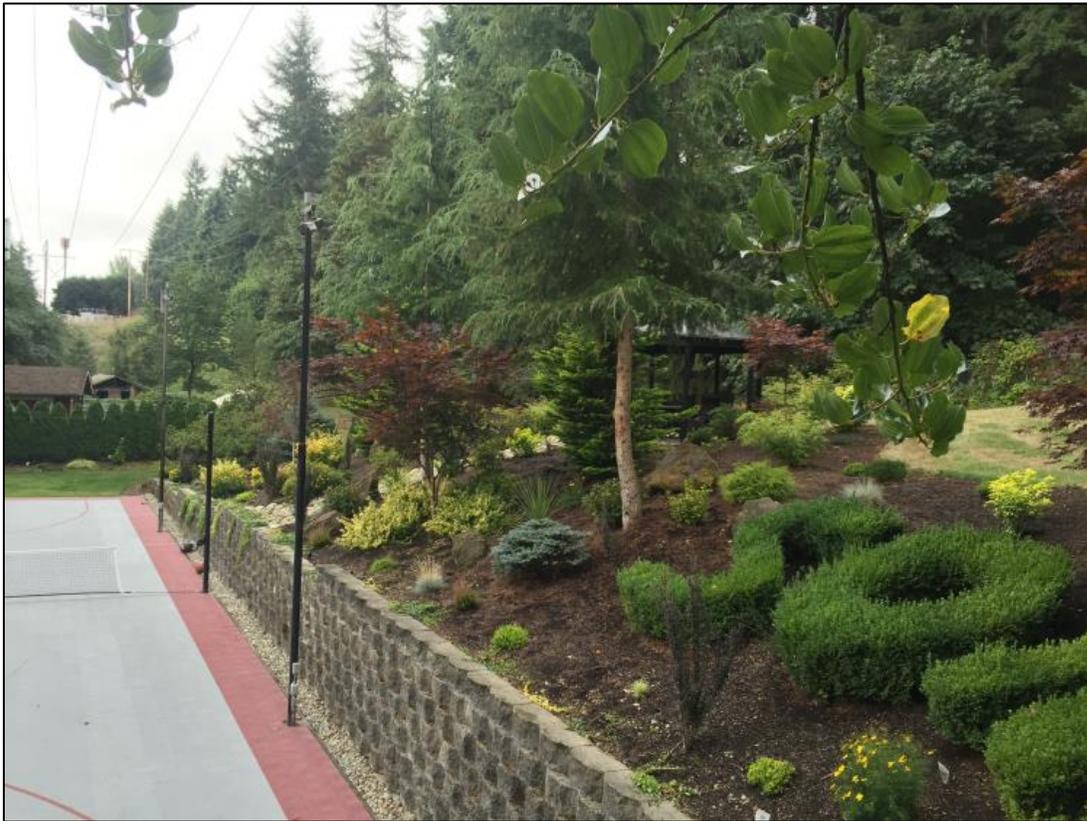
Figure 6 – A recently landscaped yard in the Bridle Trails neighborhood of Bellevue (Segment C). Several small landscape trees (tree number 4122 to 4132) were recently installed above the retaining wall. (photo taken on September 4, 2015)

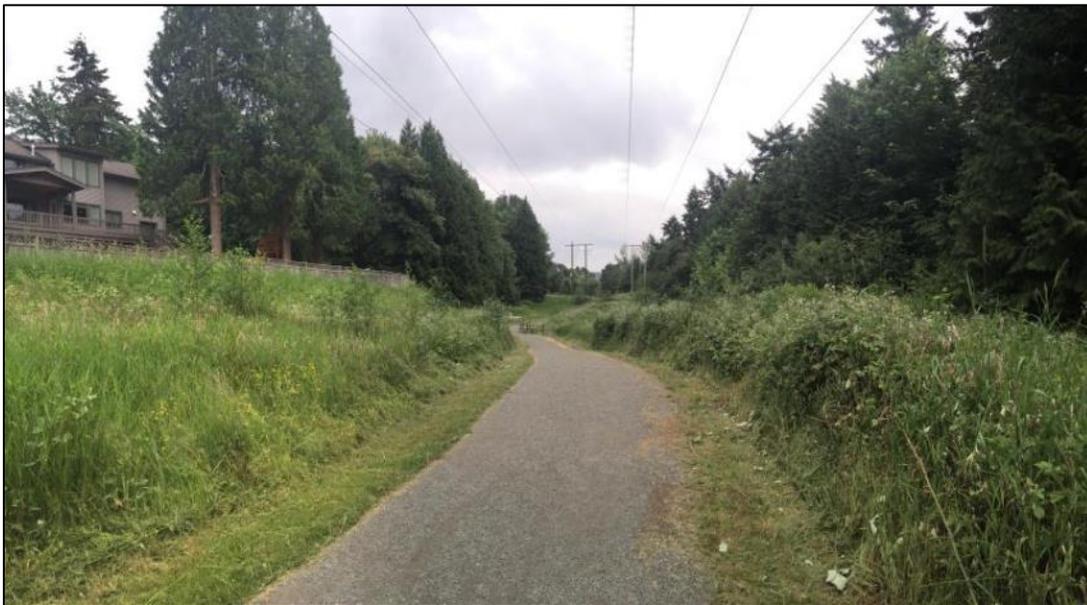
Figure 7 – The Lakes to Trails pathway under the existing lines in Segment E. Some weedy red alders are growing beneath the lines left of the trail (polygon p178). (photo taken on June 1, 2015)

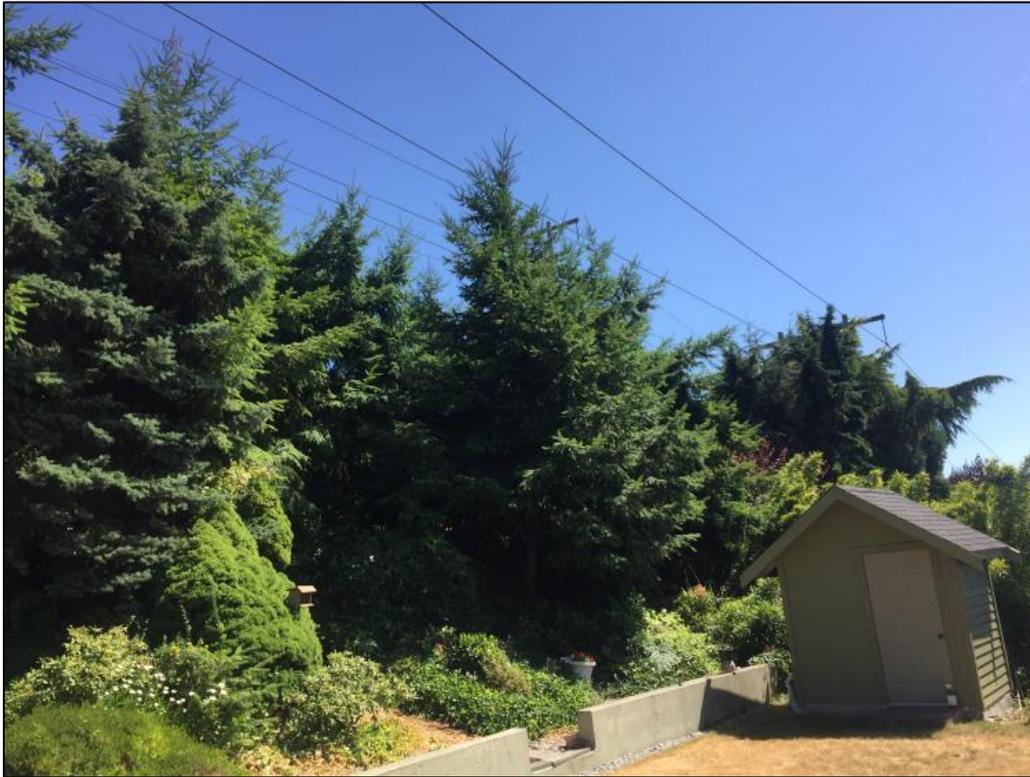
Figure 8 - A typical backyard with an easement in Segment J - the Somerset Neighborhood. Many properties had topped conifers in the easement. (photo taken on July 17, 2015)

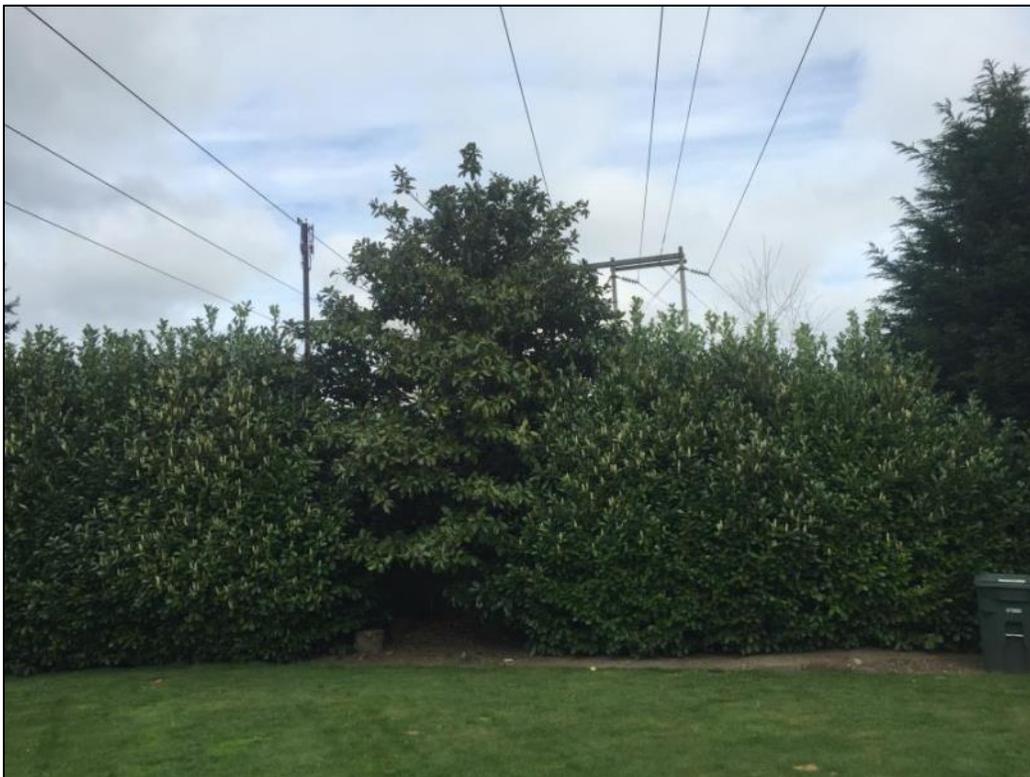
Figure 9 - A hedge of cherry laurel (polygon p31) with a southern magnolia (tree number 337) in Segment M. (photo taken on March 30, 2015)

Landscaped hedges were also described and mapped using polygons instead of tagging the individual plants that make up the hedge (Figure 9). Maintained contiguous groupings of trees and shrubs with a potential maximum height of greater than 15 feet (e.g., cherry laurel, Portuguese laurel, and arborvitae) that are growing in a row with contiguous and trimmed foliage were assessed as a polygon. Attribute data was collected for each polygon per Section 5.5 below and is included in the data table.

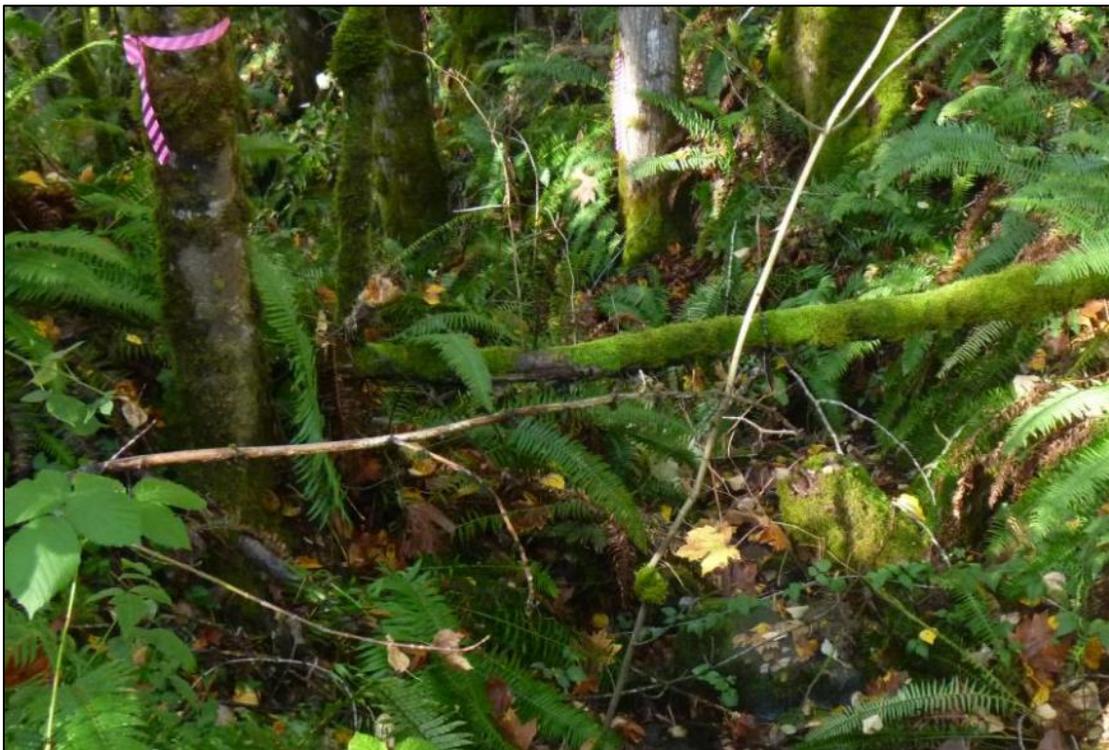
Figure 11 - Bellevue Parks Parcel in Segment K2. (Photo taken on November 3, 2015)

Only trees exhibiting a DBH of eight inches or greater were included in this sub area (Figure 11). This alteration to the methodology was agreed upon in order to
