# CITY OF NEWCASTLE TREE INVENTORY REPORT

## Puget Sound Energy – Energize Eastside Project

May 2016

**The Watershed Company Reference Number:**  
**111103.2**

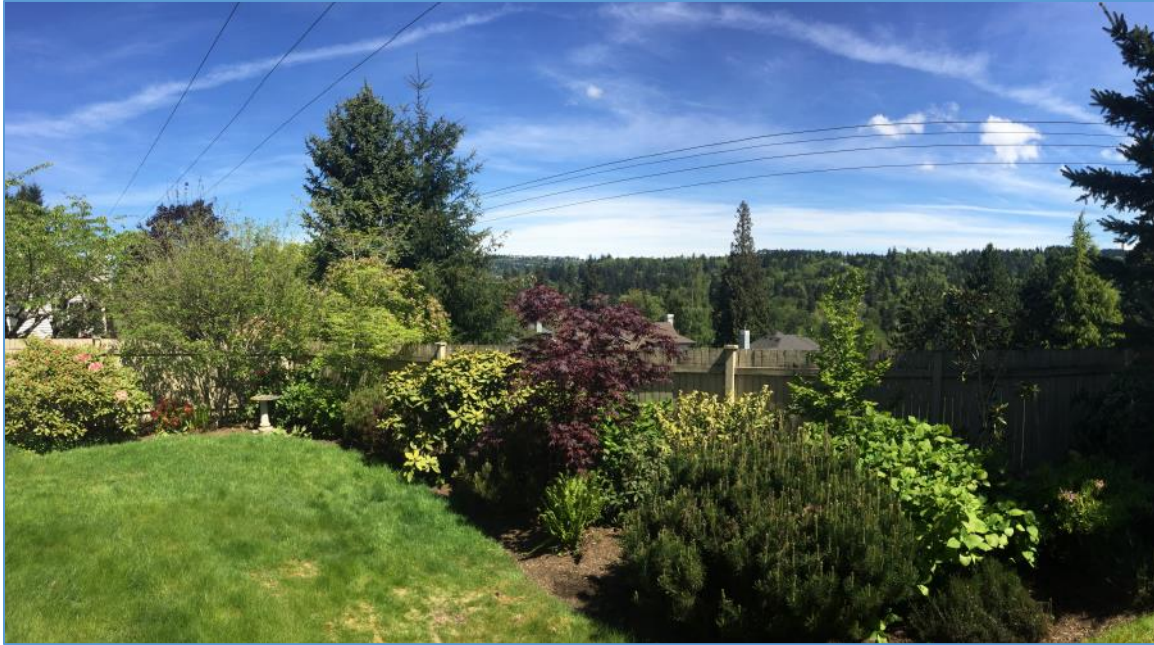
Figure 3 - Typical landscaped yard in the Olympus neighborhood of the City of Newcastle. Several small landscaped trees were tagged here. (photo taken April 27, 2015)

The study area in the City of Newcastle includes residential areas and May Creek Park, generally zoned Residential (R-6) and Limited Open Space (LOC), respectively. At the north end, the corridor passes through the Donegal and Olympus neighborhoods (Figure 3) before crossing May Creek Park (Figure 4) situated at the south end of the City. The study area is located in Township 24N, Range 05E, Sections 28 and 33.

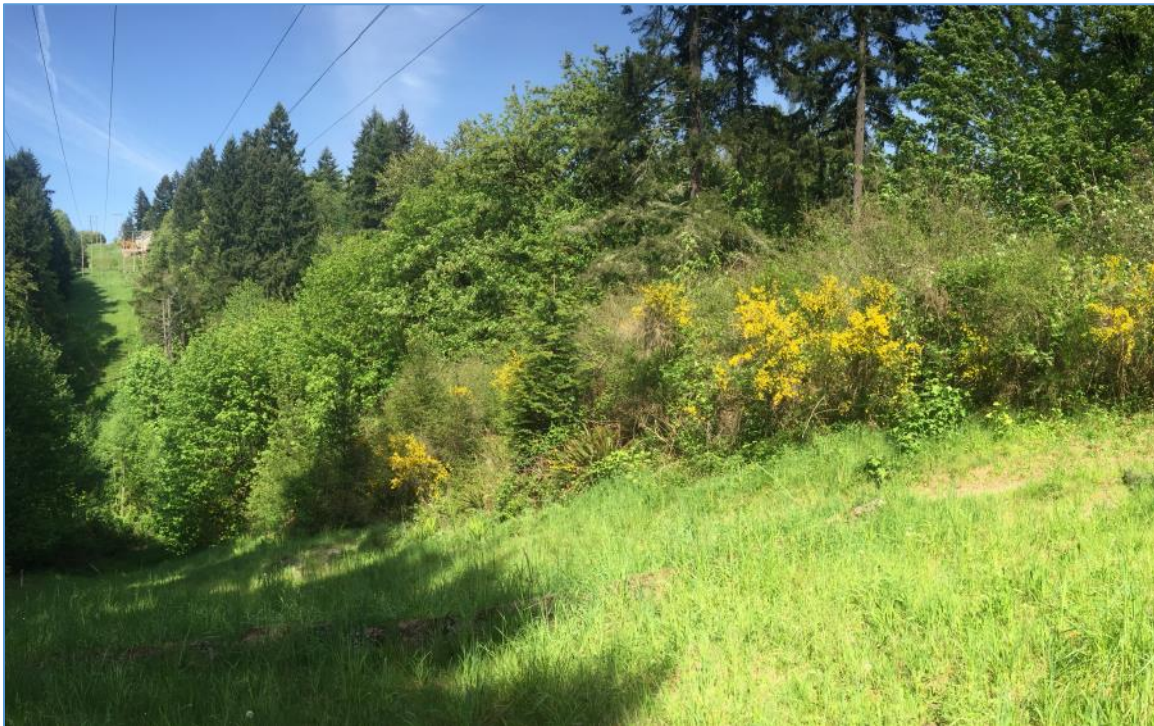
Figure 4 - A photo from the south edge of the May Creek Ravine, looking north. (photo taken May 4, 2015)

Vegetation in the corridor is generally limited to landscaped beds and maintained yards. However, some larger undeveloped and Park parcels in the City contain Himalayan blackberry, grass and small saplings. The May Creek Park portion of the Segment is an example. The lowest portion of the May Creek ravine retains some tall trees as the height of the lines in this area is more than 100 feet above the surface of the ground.

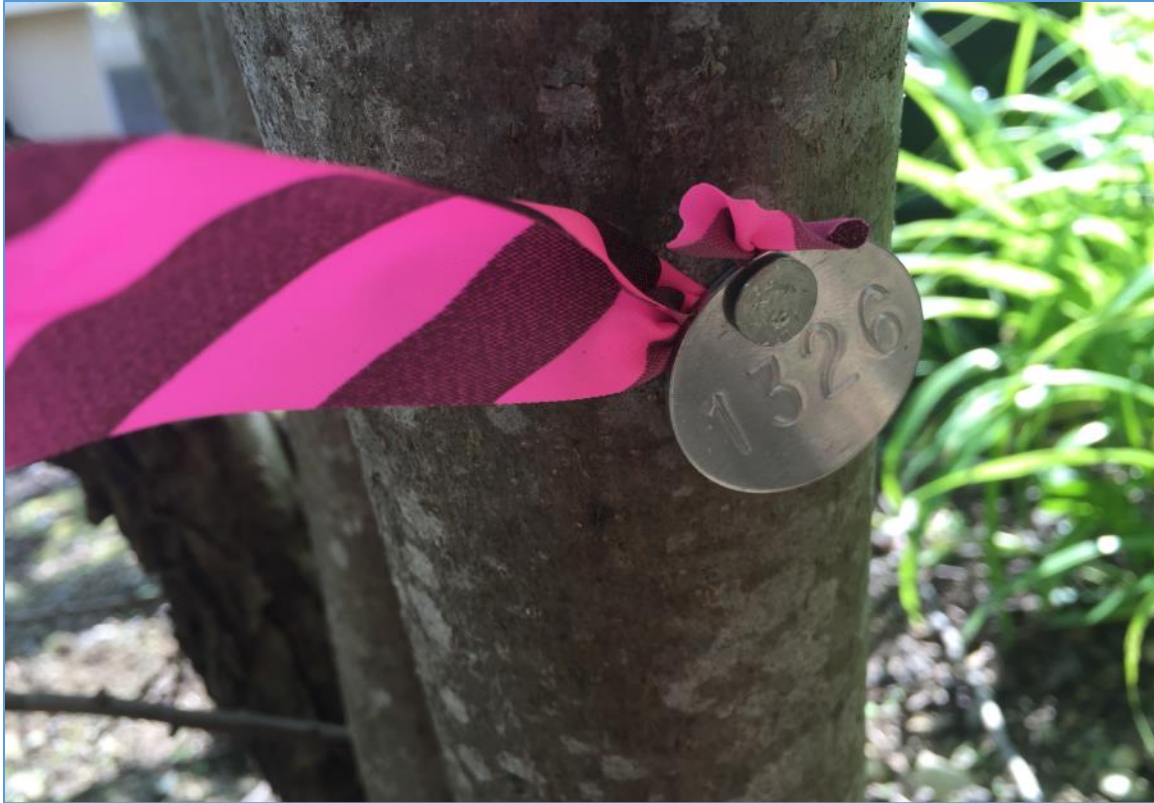
Figure 5 - An example of the aluminum tag with bright flagging. (photo taken May 4, 2015)

In order to achieve a more inclusive look at trees within the corridor, any tree with a diameter of six inches at four-and-a-half feet above the surface of the ground (DBH) was tagged and included. A round one-and-one-quarter-inch-wide, numbered aluminum tag was affixed to the trunk of significant trees using a two-and-one-quarter-inch long aluminum nail (Figure 5). Where property owners would not allow nailing, a small wire tie was used to affix the tag to a lateral branch or smaller shoot near the trunk. For a majority of the tags, a length of pink- and black-stripped flagging was included behind the tag to aid survey crews in visually locating the subject trees. Survey crews removed the bright flagging once the tree was survey-located.

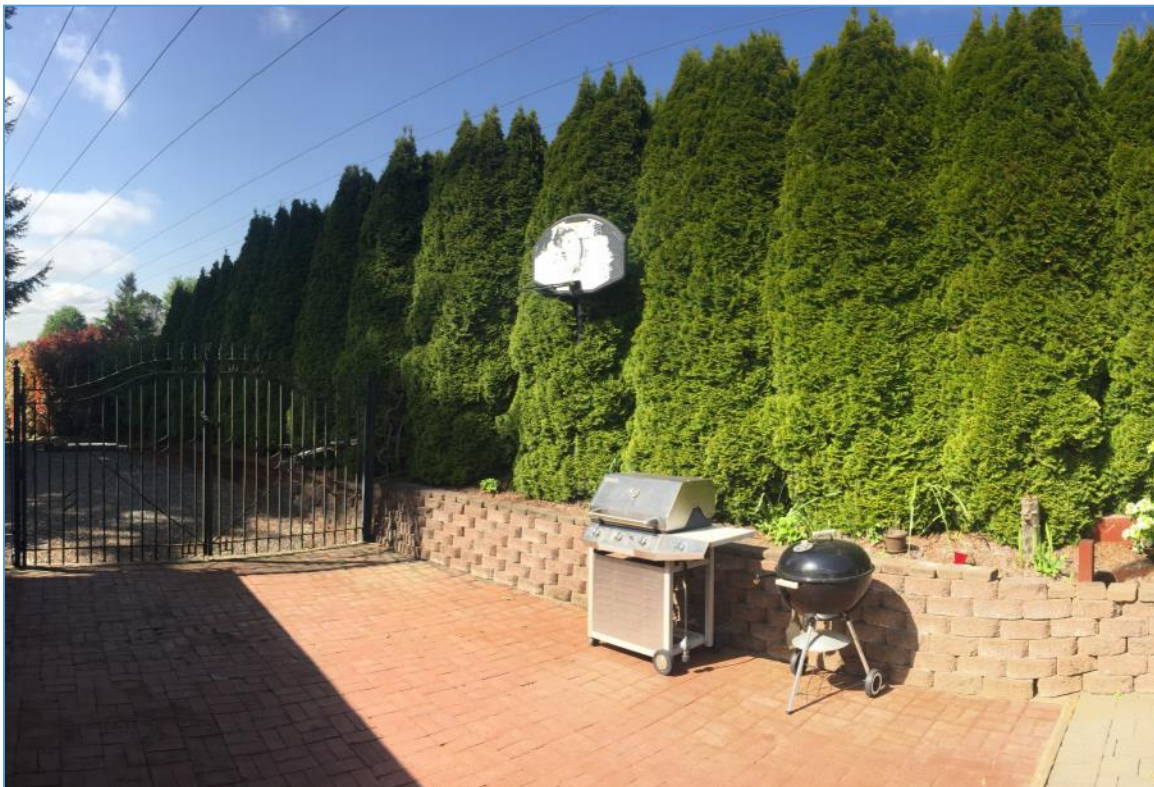
Figure 6 - A hedge of arborvitae in the Olympus Neighborhood (polygon number p135). (photo taken May 4, 2015)

Landscaped hedges were also described and mapped using polygons instead of tagging the individual plants that make up the hedge (see Figure 6). Groupings of trees and shrubs with a potential maximum height of greater than 15 feet growing in a row with contiguous and trimmed foliage, regardless of the maintained height, were assessed as a polygon. Attribute data was collected for each polygon per Section 5.5 below and is included in the data table.
