# CITY OF REDMOND TREE INVENTORY REPORT

## Puget Sound Energy – Energize Eastside Project

May 2016

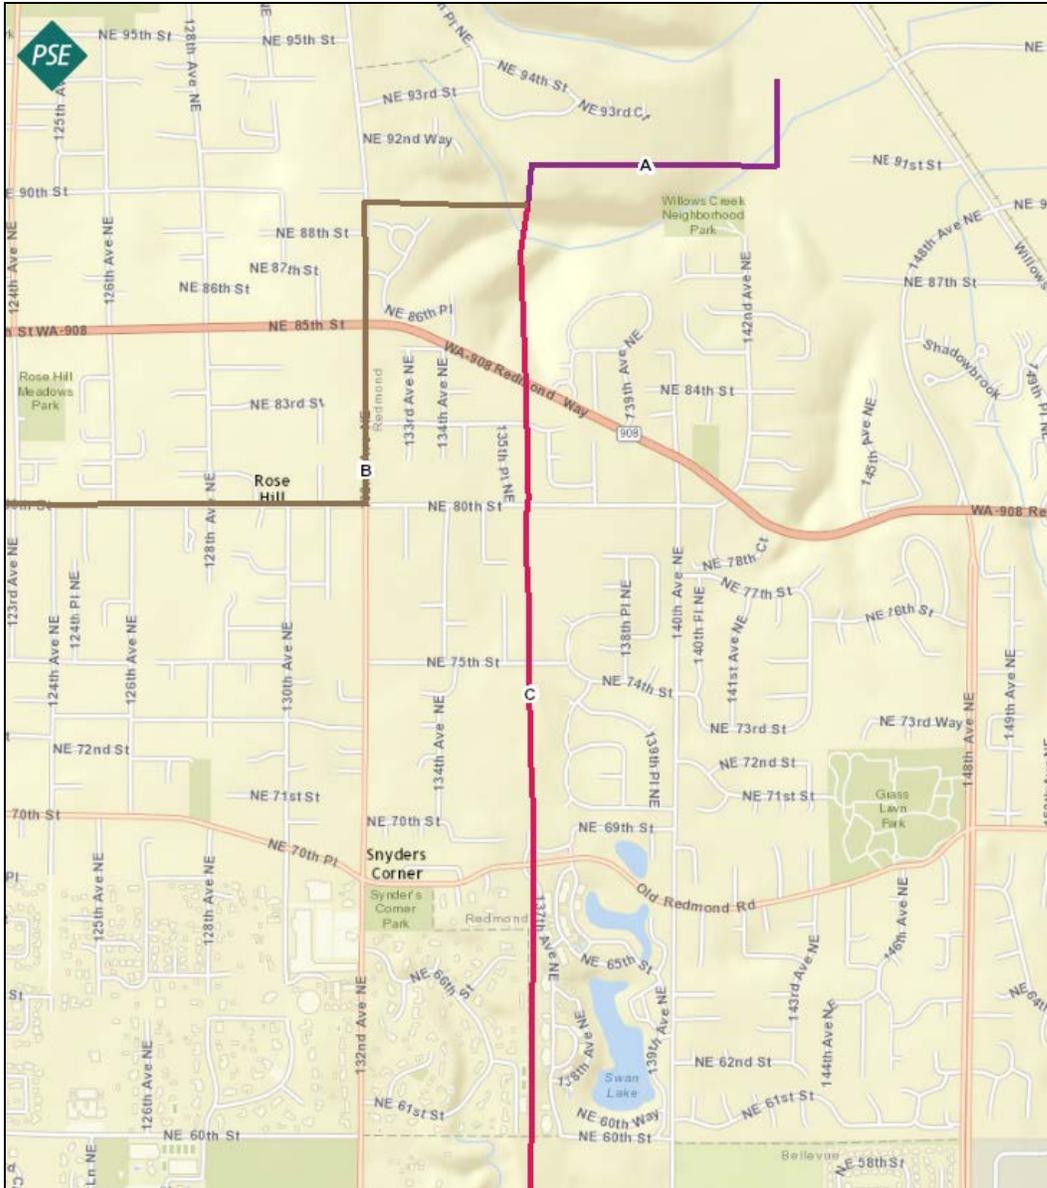
Figure 2 - Overview of the study area corridor in the City of Redmond including Segment A and the northern portion of Segment C.

The City of Redmond portion includes PSE-labeled Segments A and the north end of Segment C (portions of Phase 2 DEIS Segment 1). The length of the corridor in the City of Redmond is approximately 2.1 miles, beginning at the Sammamish substation and running west and south to approximately NE 60th Street (Figure 2). The study area is an approximately 100-foot wide easement that includes two existing sets of 115kV transmission lines. These sets, consisting of three conductors (wires) each, are spaced approximately 50 feet apart on-center in most areas; H-frame pole structures carry each set of transmission lines. The sets diverge such that they are more than 50 feet apart in Segment A near the Sammamish substation.

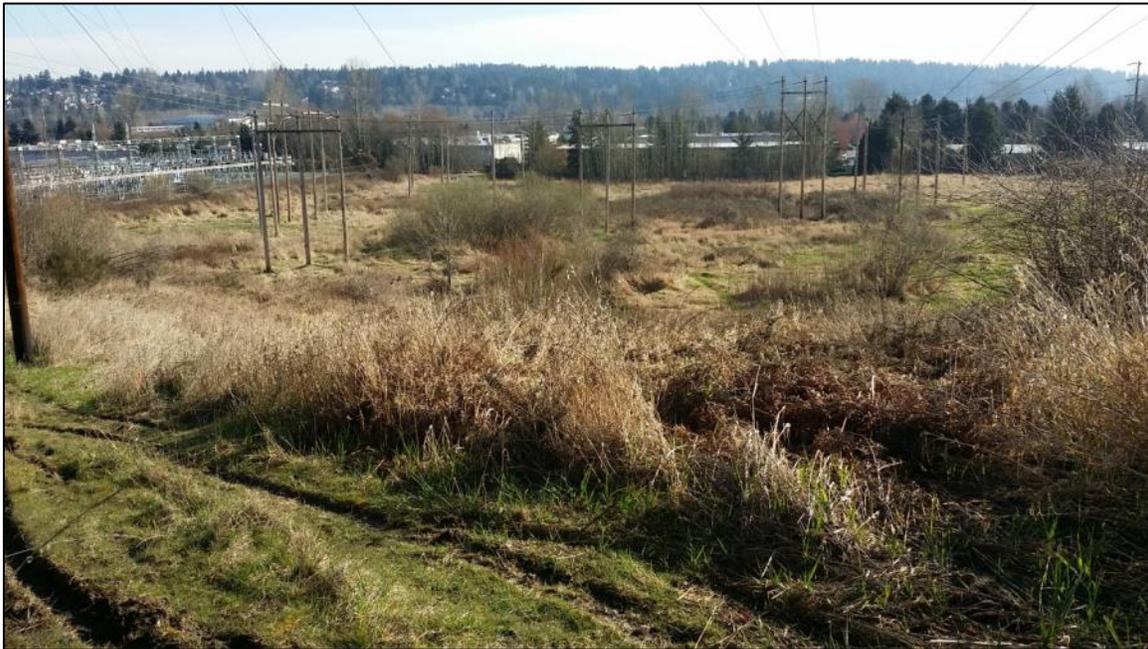
Figure 3 - Vegetation in Segment A with the Sammamish substation in the background. Some small willow saplings are rooted in the project area. (photo taken March 10, 2015)

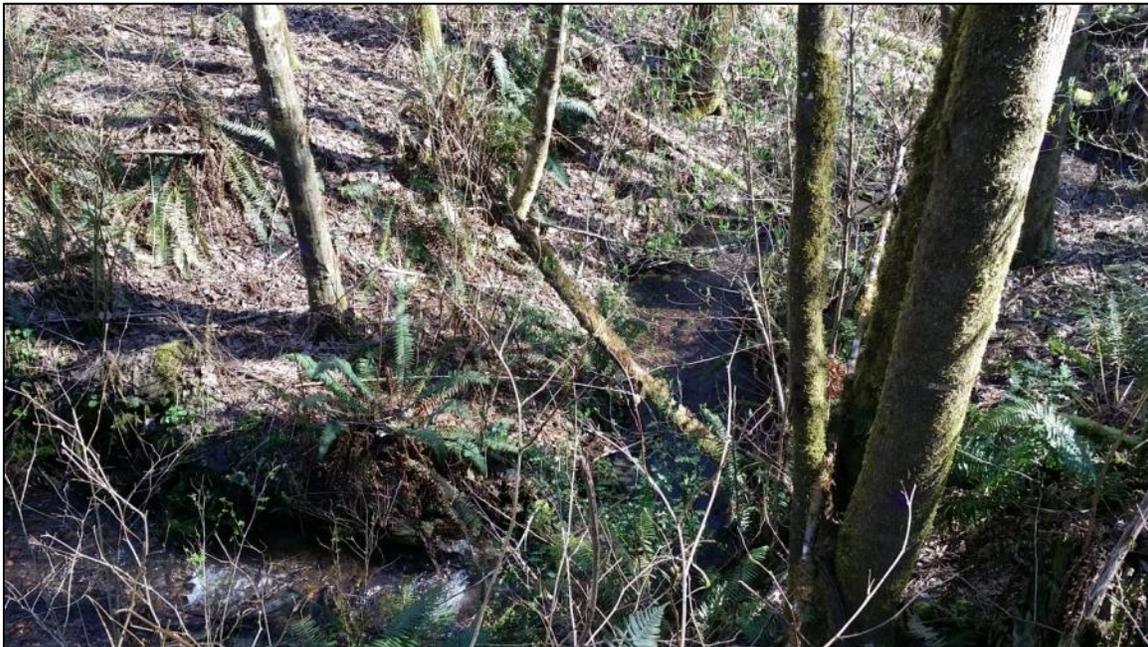
Figure 4 - Red alders in the ravine north of Redmond Way in Segment C. These trees are located beneath existing lines in the subject area (photo taken March 10, 2015)

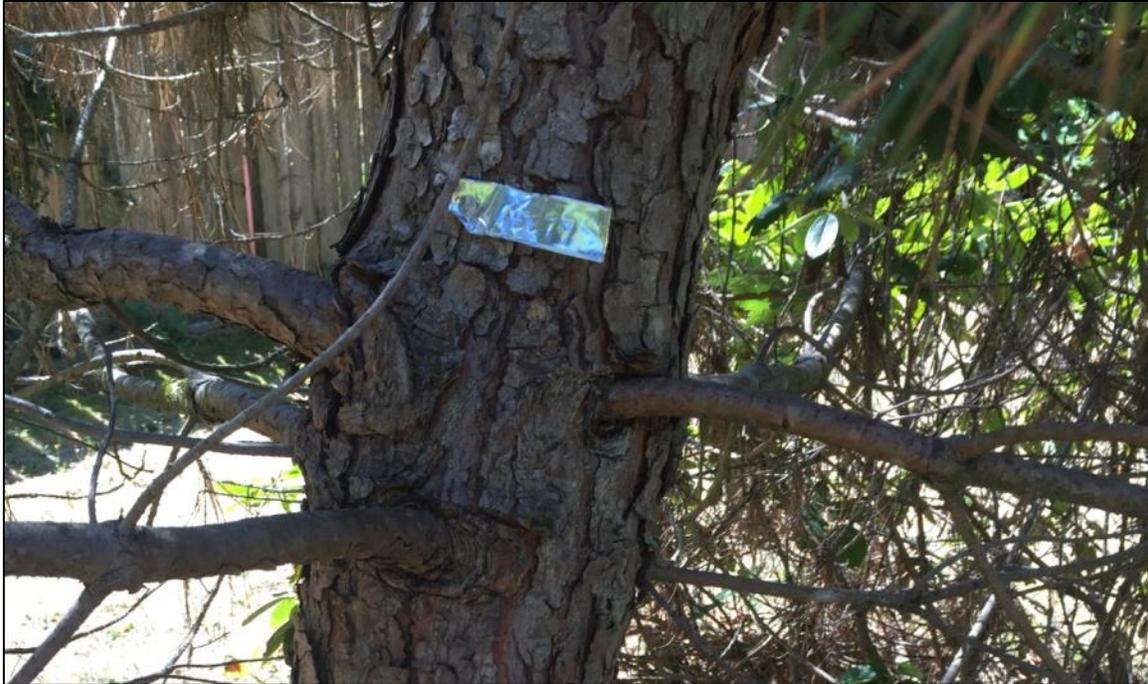
Figure 5 - An APS-tagged significant tree in the Grass Lawn neighborhood of Redmond.  
(photo taken August 19, 2015)

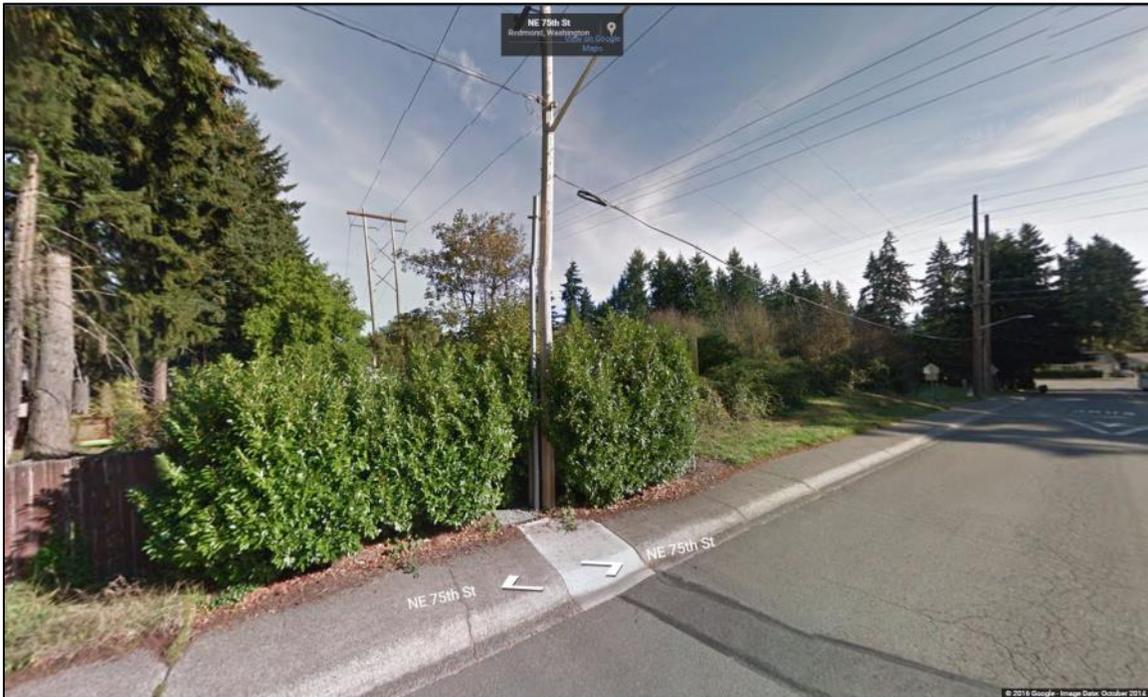
Figure 6 - A Google Streetview image of a cherry laurel hedge (polygon p292) in the PSE easement. This photo is looking northeast from NE 75th Street in Segment C. (Google, 2016)

Landscaped hedges were also described and mapped using polygons instead of tagging the individual plants that make up the hedge (Figure 6). Groupings of trees and shrubs with a potential maximum height of greater than 15 feet growing in a row with contiguous and trimmed foliage, regardless of the maintained height, were assessed as a polygon. Attribute data was collected for each polygon per Section 5.5 below and is included in the data table.
