CITY OF RENTON TREE INVENTORY REPORT

Puget Sound Energy – Energize Eastside Project

May 2016

The Watershed Company Reference Number:
111103.2

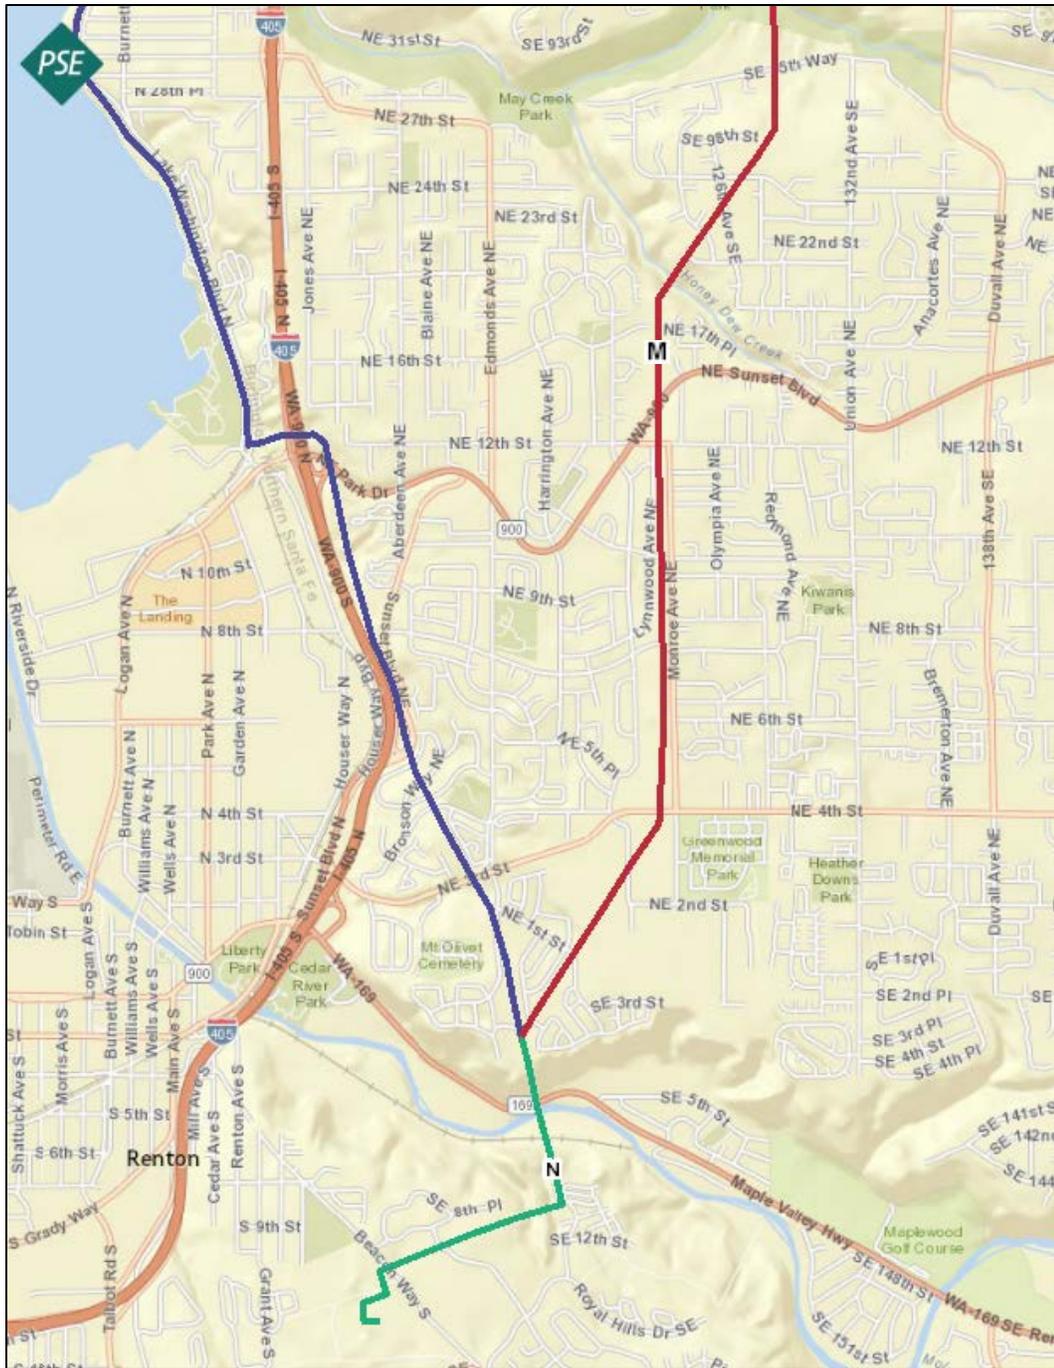
Figure 2 - Overview of the study area corridor in the City of Renton including the southern portion of Segment M (red) and Segment N (green).

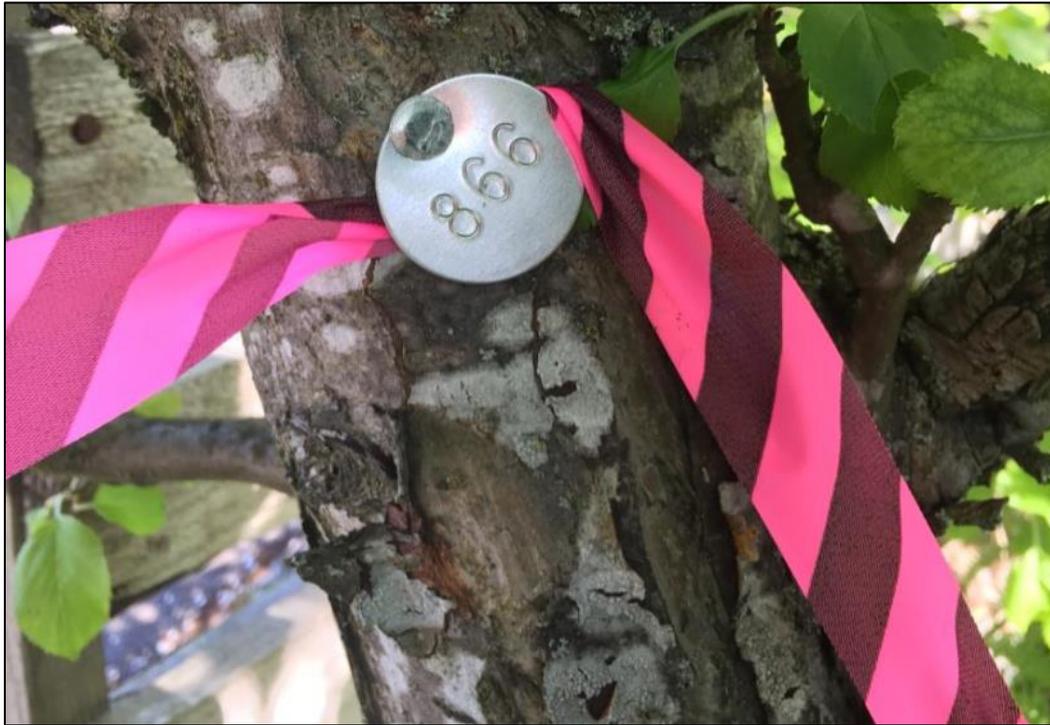
Figure 3 - A five-inch DBH apple tree tagged in Segment M in the City of Renton. (Photo taken April 17, 2015)

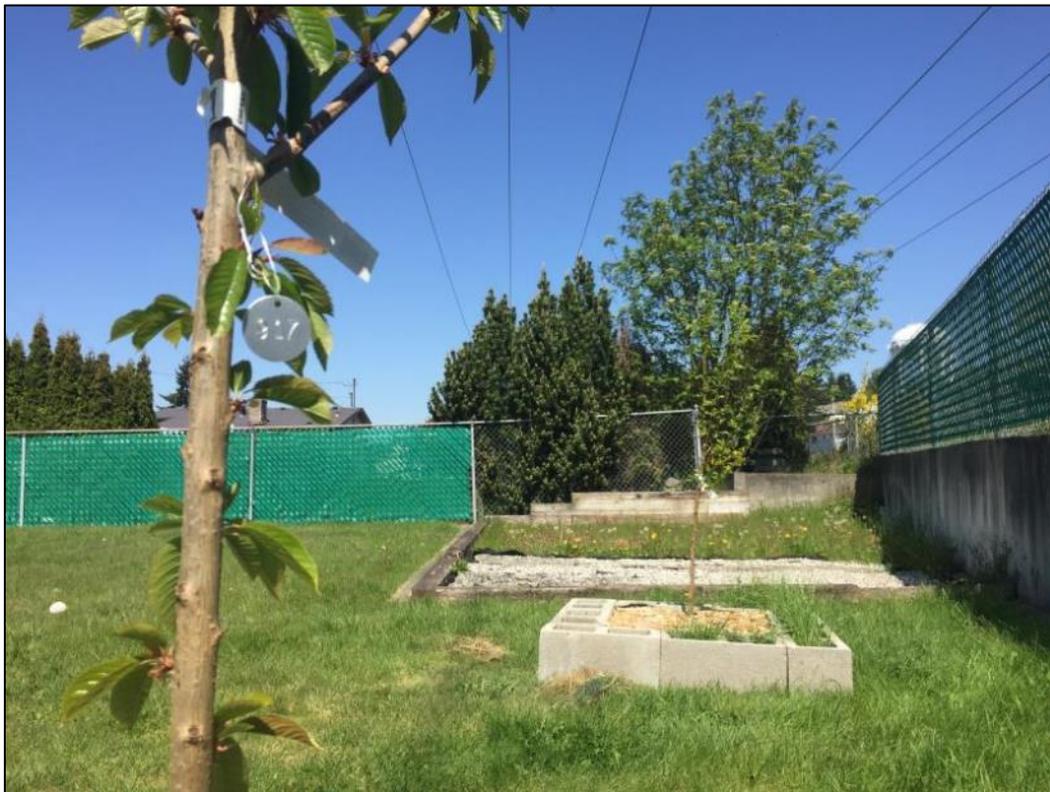
Figure 4 – A 0.75-inch caliper fruiting cherry tree that was recently installed in a residential back yard in the City of Renton (#917). This tree, although small, has a maximum potential height of 25 feet. (Photo taken April 20, 2015)

aluminum tag was affixed to the trunk with a nail where possible. If the trunk diameter was smaller than two inches, generally the aluminum tag was affixed to the trunk or a branch near the trunk using a wire tie (Figure 4).

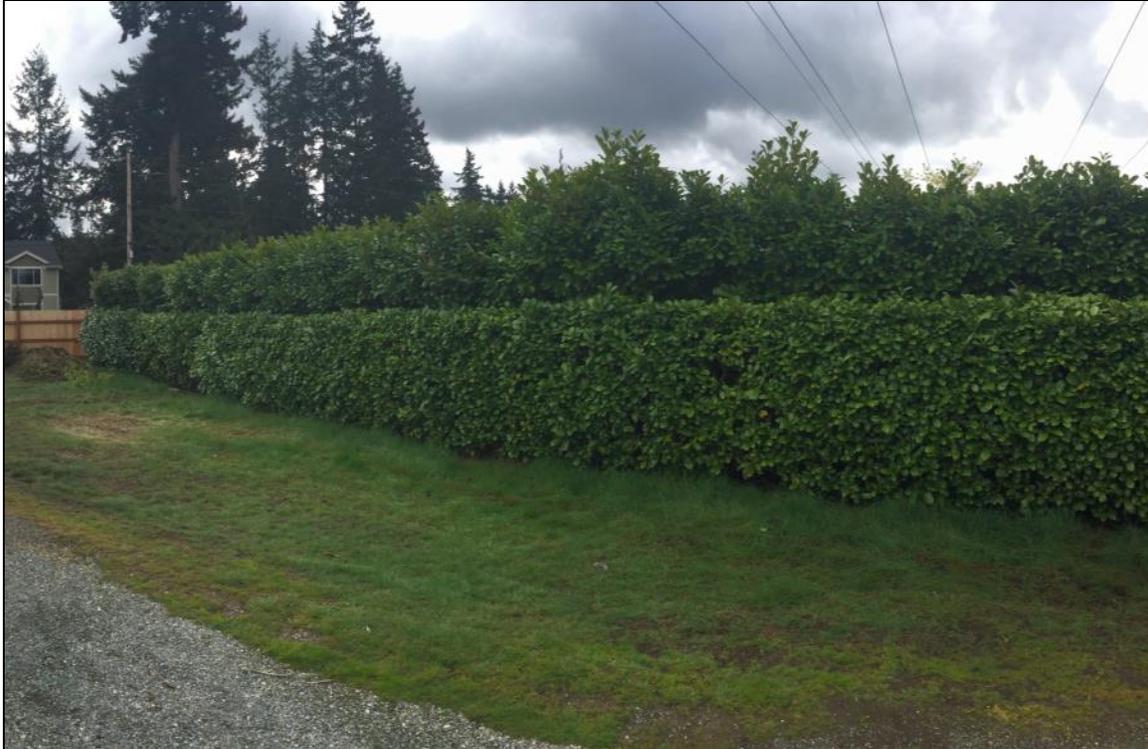
Figure 5 – A typical hedge of cherry laurel in Segment M in the City of Renton that was assessed and mapped as a polygon (polygon number p106). (photo taken April 20, 2015)

Landscaped hedges were also described and mapped using polygons instead of tagging the individual plants that make up the hedge (Figure 6). Maintained contiguous groupings of trees and shrubs with a potential maximum height of greater than 15 feet growing in a row as a hedge, regardless of the maintained height, were assessed as a polygon. Attribute data was collected for each polygon per Section 5.5 below and is included in the data table.

Many of the polygons in Segment M describe landscape hedges composed of arborvitae, cherry laurel, and Fraser photinia (Figure 6). But some non-hedged beaked hazelnut, black cottonwood, red alder and common hawthorn are also captured.

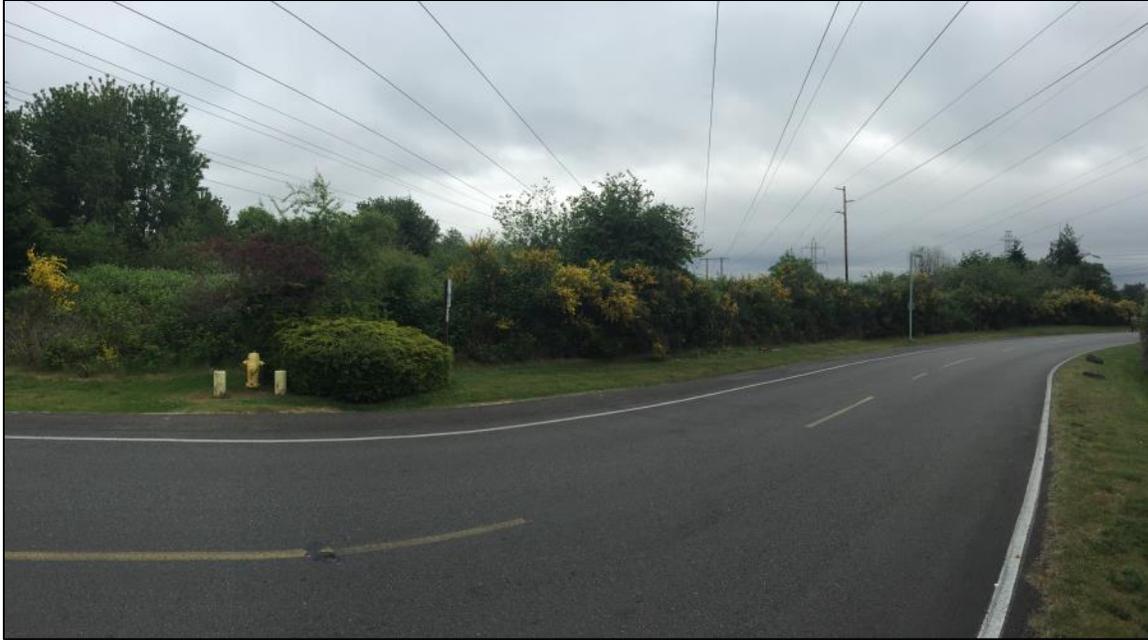
Figure 7 - Cedar Ridge Dr SE in Segment N with the existing transmission lines overhead, looking east. (photo taken May 22, 2015)

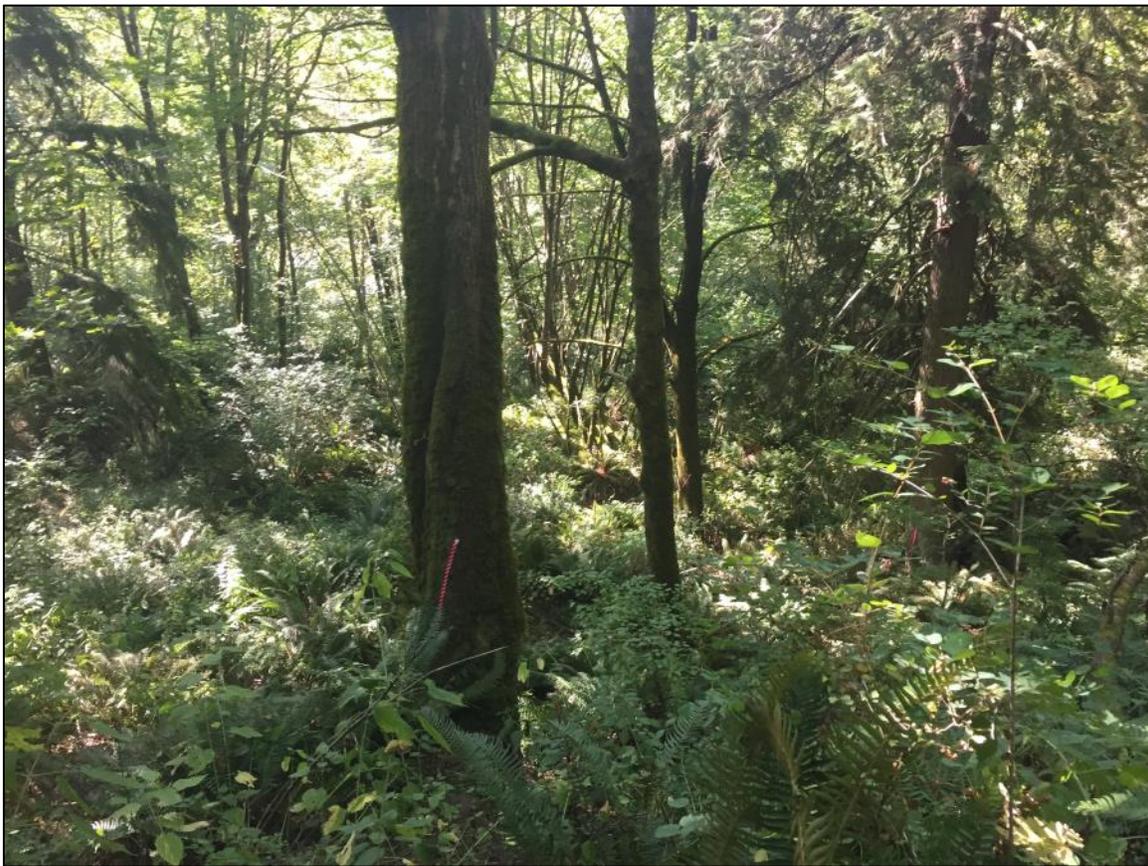
Figure 8 - Larger trees growing in the Segment N easement on the north wall of the Cedar River valley, looking south. (photo taken August 27, 2015)
