SEGMENT O TREE INVENTORY REPORT

Puget Sound Energy – Energize Eastside Project

May 2016

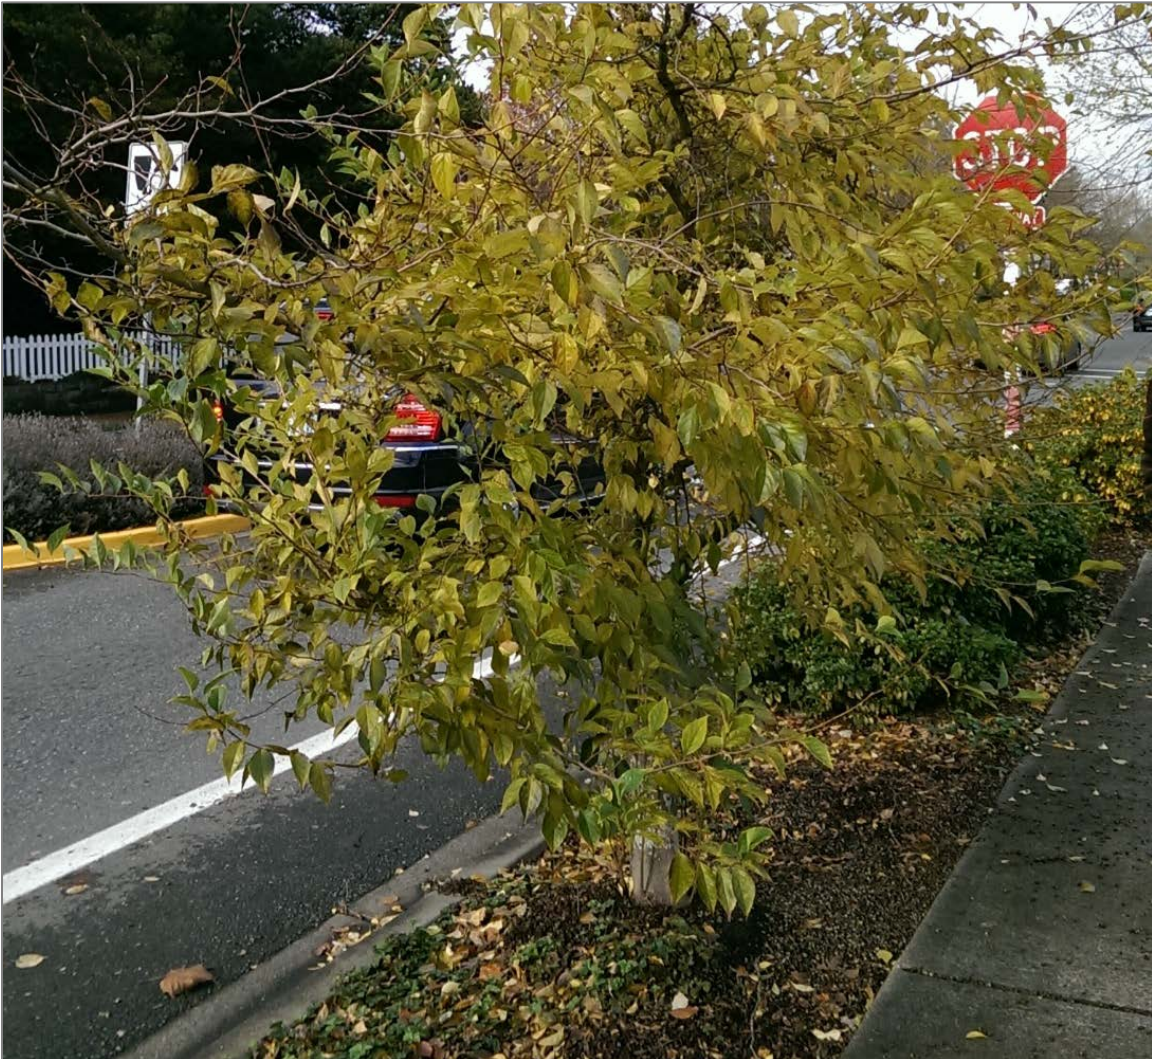
Figure 3 – Looking northwest planting strip vegetation at the southeast corner of 124th Ave SE and SE 41st Pl. (Photo taken November 16, 2016)

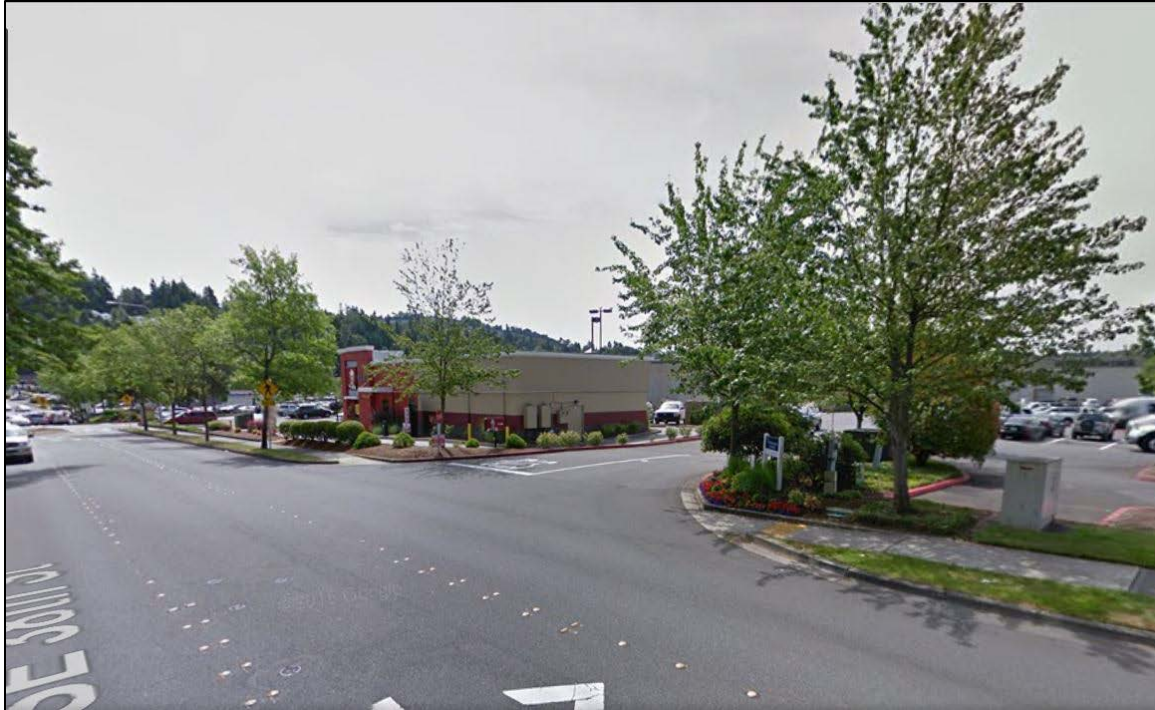
Figure 4 – A Google Street View image of the Norway maple trees that line the south side of SE 38th St in Segment O. (Photo courtesy of Google Maps, 2016)

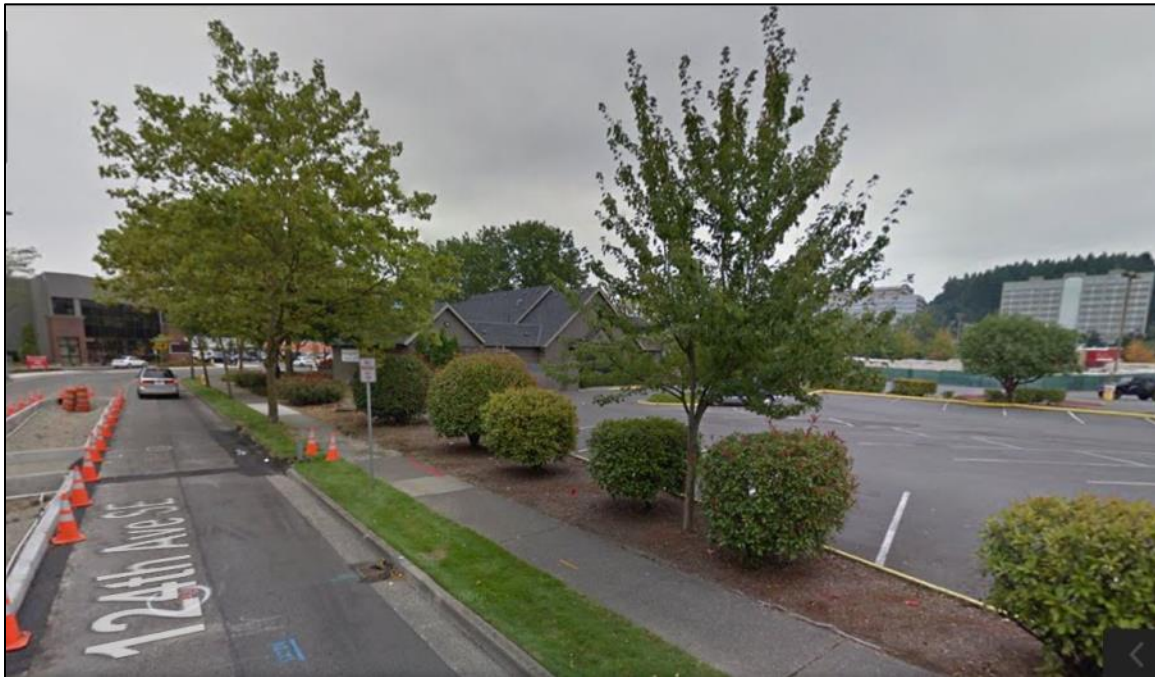
Figure 5 - Google Street View image showing a red maple and American sycamore tree, along with hedged Fraser photinia (p614) along the east side of 124th Ave SE just south of SE 38th St in Segment O. (Photo courtesy of Google Maps, 2016)

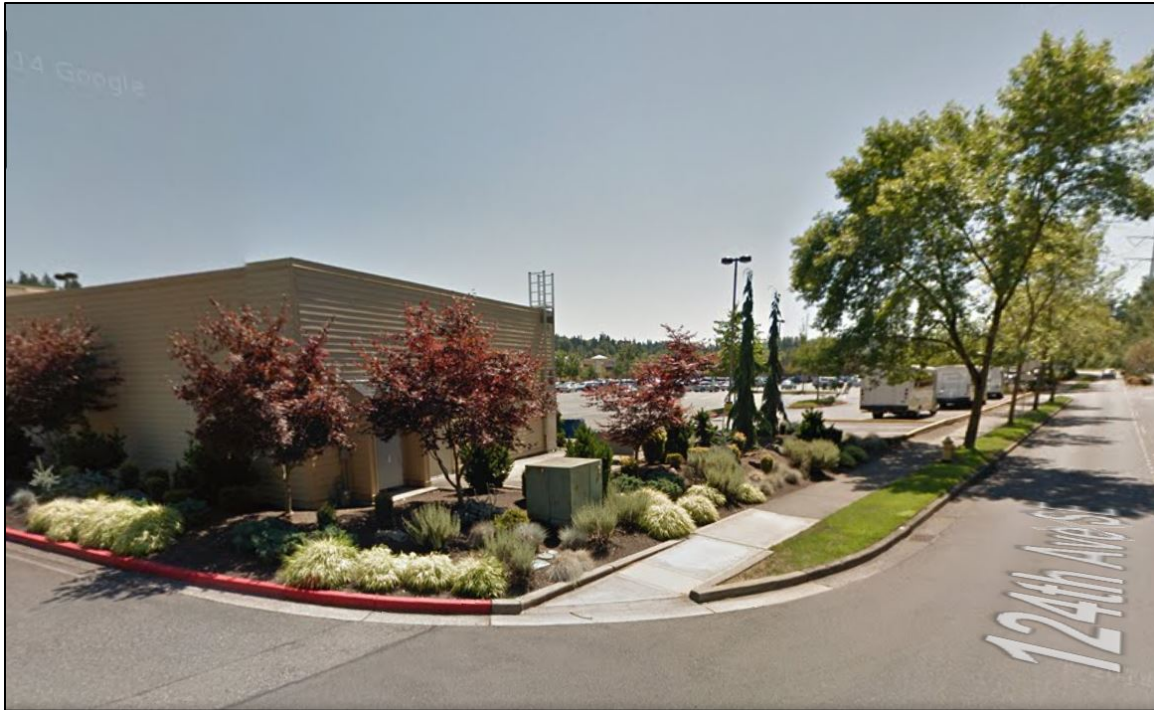
Figure 6 – A Google Street View image showing a landscaped area at the southeast corner of 124th Ave SE and an entrance to the Factoria Mall. Japanese Maples and Alaska cedars are located in the study area here. (Photo courtesy of Google Maps, 2016)

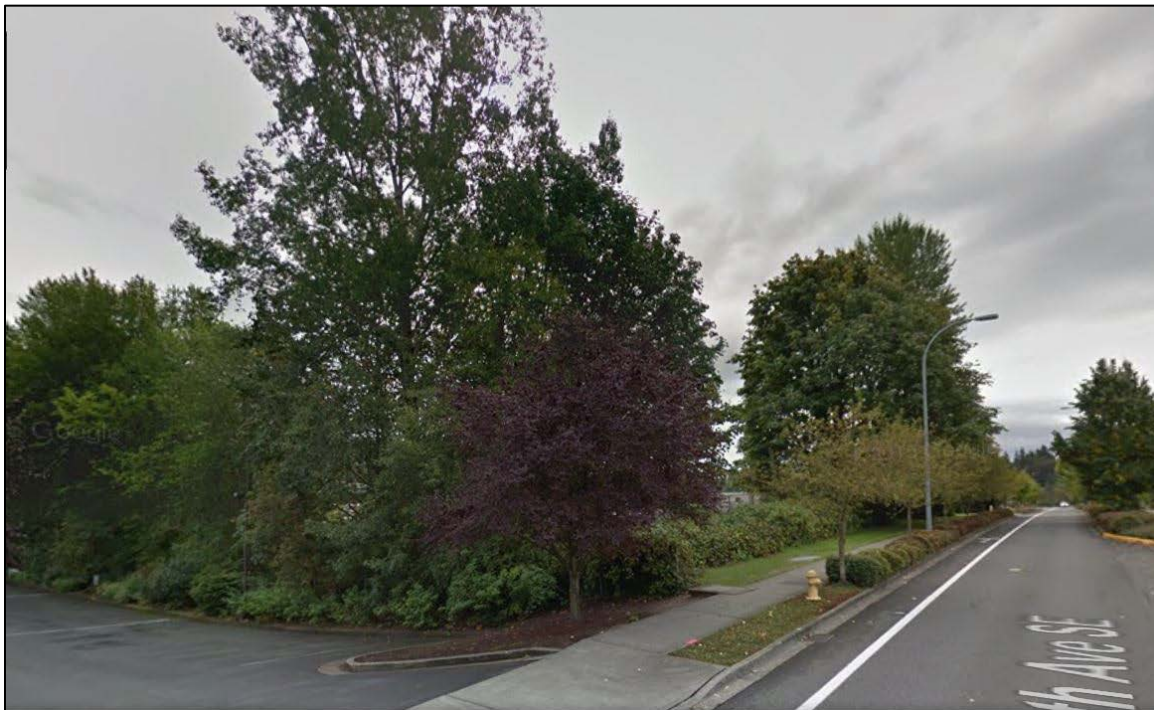
Figure 7 - Google Street View showing the small patch of native trees at the northwest corner of Newport High School (Photo courtesy of Google Maps, 2016)

The Segment O study area contains 211 trees; 101 of which currently meet the City's significant tree definition. The largest, a 23-inch black cottonwood, is located in the small native patch of vegetation at the northwest corner of the Newport High School property. The most common trees along the corridor are American sycamore, red oak, and red and Norway maples. Several apple, vine maple and Douglas-fir trees are also rooted in planting strips along 124th Ave SE.
